# **Wignell Drain Stormwater Baseline Report**

Project No: EWB-189999

**EWA Engineering Inc.**

**City of Port Colborne  
Wignell Drain Baseline Report**

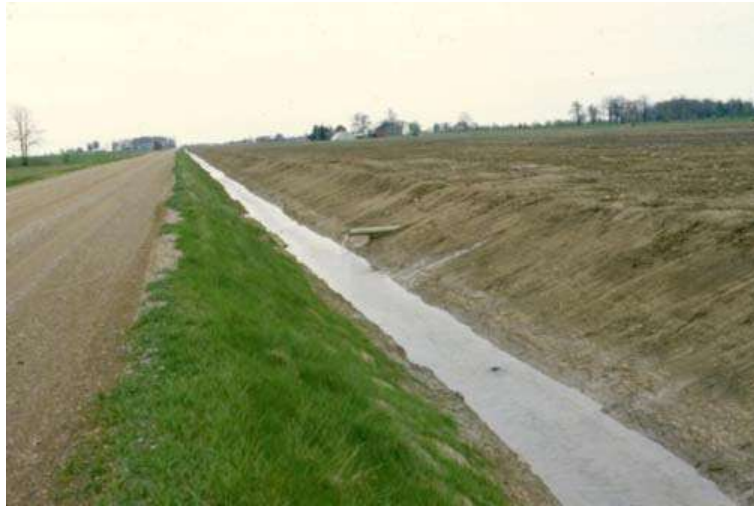
**Figure 5 Example of clear drain**

The objective of a drain is to provide a clear unobstructed flow with depth to provide adequate private drain connection outlets. The following image exemplifies a traditional “good” drain profile and cross-section with contributory flows from a tile drain connected to the drain.

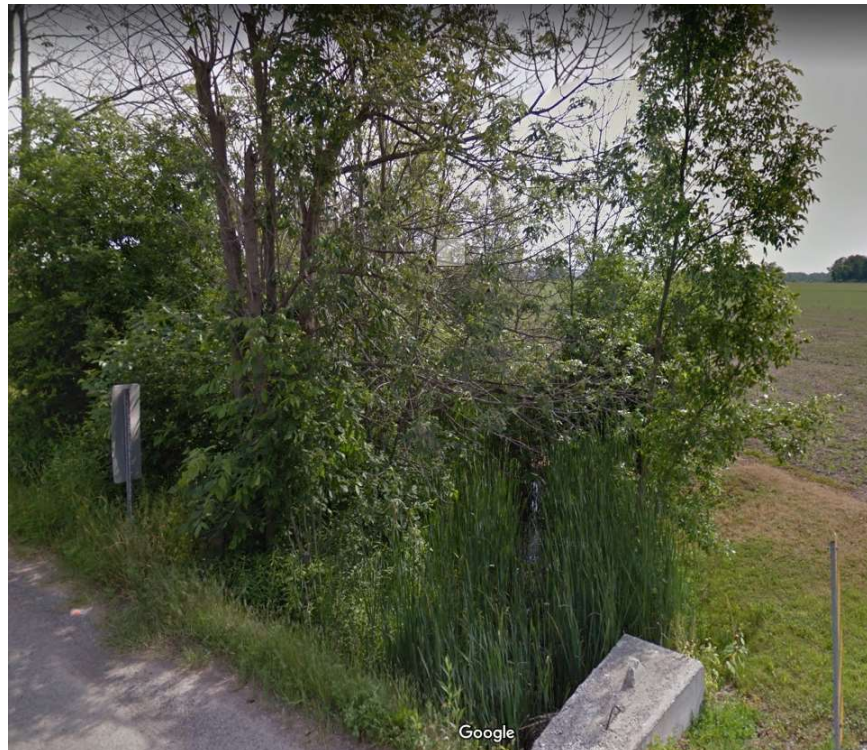
**Figure 6 Obstructed drain; Wignell @ East side of Weaver Road**  
This flow is obstructed by tree growth within the banks. Bull rushes provide evidence of standing water. The expected performance of the culvert based on this approach is compromised and unlikely to perform as designed or expected.

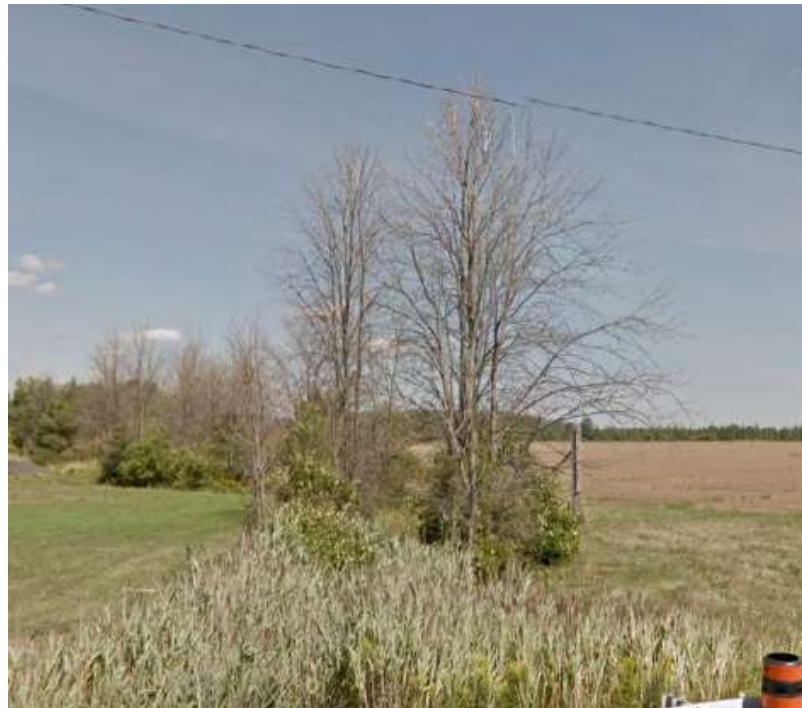
**Figure 7 Dead Ash trees within drain banks**

The presence of ash trees allowed to grow within the drain banks previously, which are now dead or dying from the emerald ash borer will provide a source of wood debris that may potentially block the drain and cause backwater or other degradations in performance.

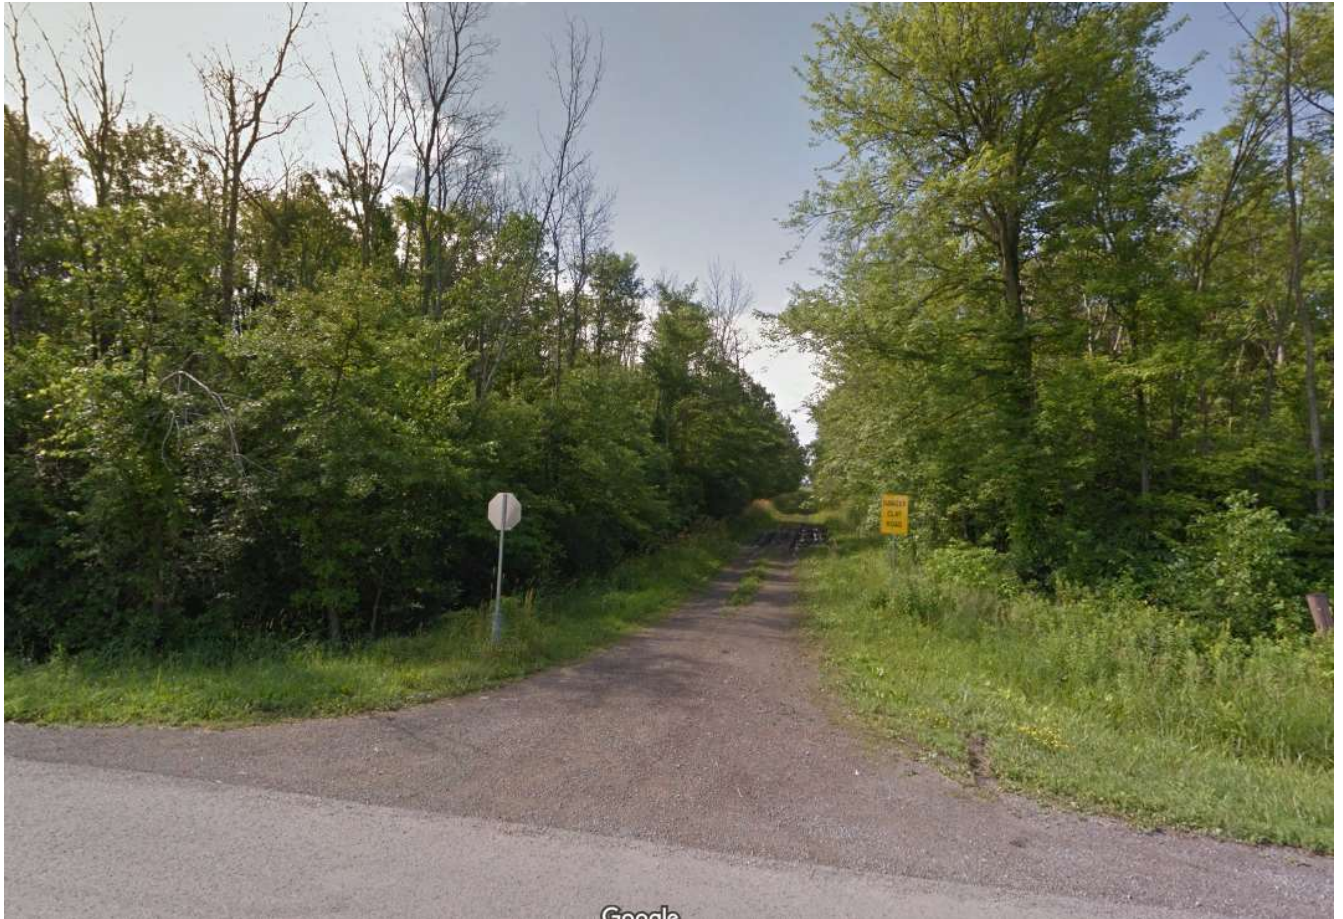
**Figure 8 Wignell Drain Upper end @ Carl Road (clay) and Second Concession Rd.**

The above figure shows that the drain is completely obscured by tree and other growth such that there's little if any discernible evidence that a drain exists. However, complete removal of all vegetation may not be a good objective from an environmental benefit or function. While the drain operates best if there are smooth banks and no obstructions to flow, it will continue to operate even with some obstructions to flow. From a drain recovery aspect, improving the drain function while continuing to meet an environmental benefit, the working portion of the drain, the low flow channel should have all trees removed. Approximately the ½ way point up the bank, all trees should be removed, while the upper portion of the bank can maintain a healthy tree. This is modified with a simple approach, that there exists, such as shown above in figure, a working side to provide drain maintenance. In this case, specific to the Wignell drain, where the drain is running adjacent to the road allowance for Carl Road, trees can be accommodated along the upper bank portion provided access for future maintenance is available from the road allowance. Obviously, this does not apply once the drain leaves the road allowance.

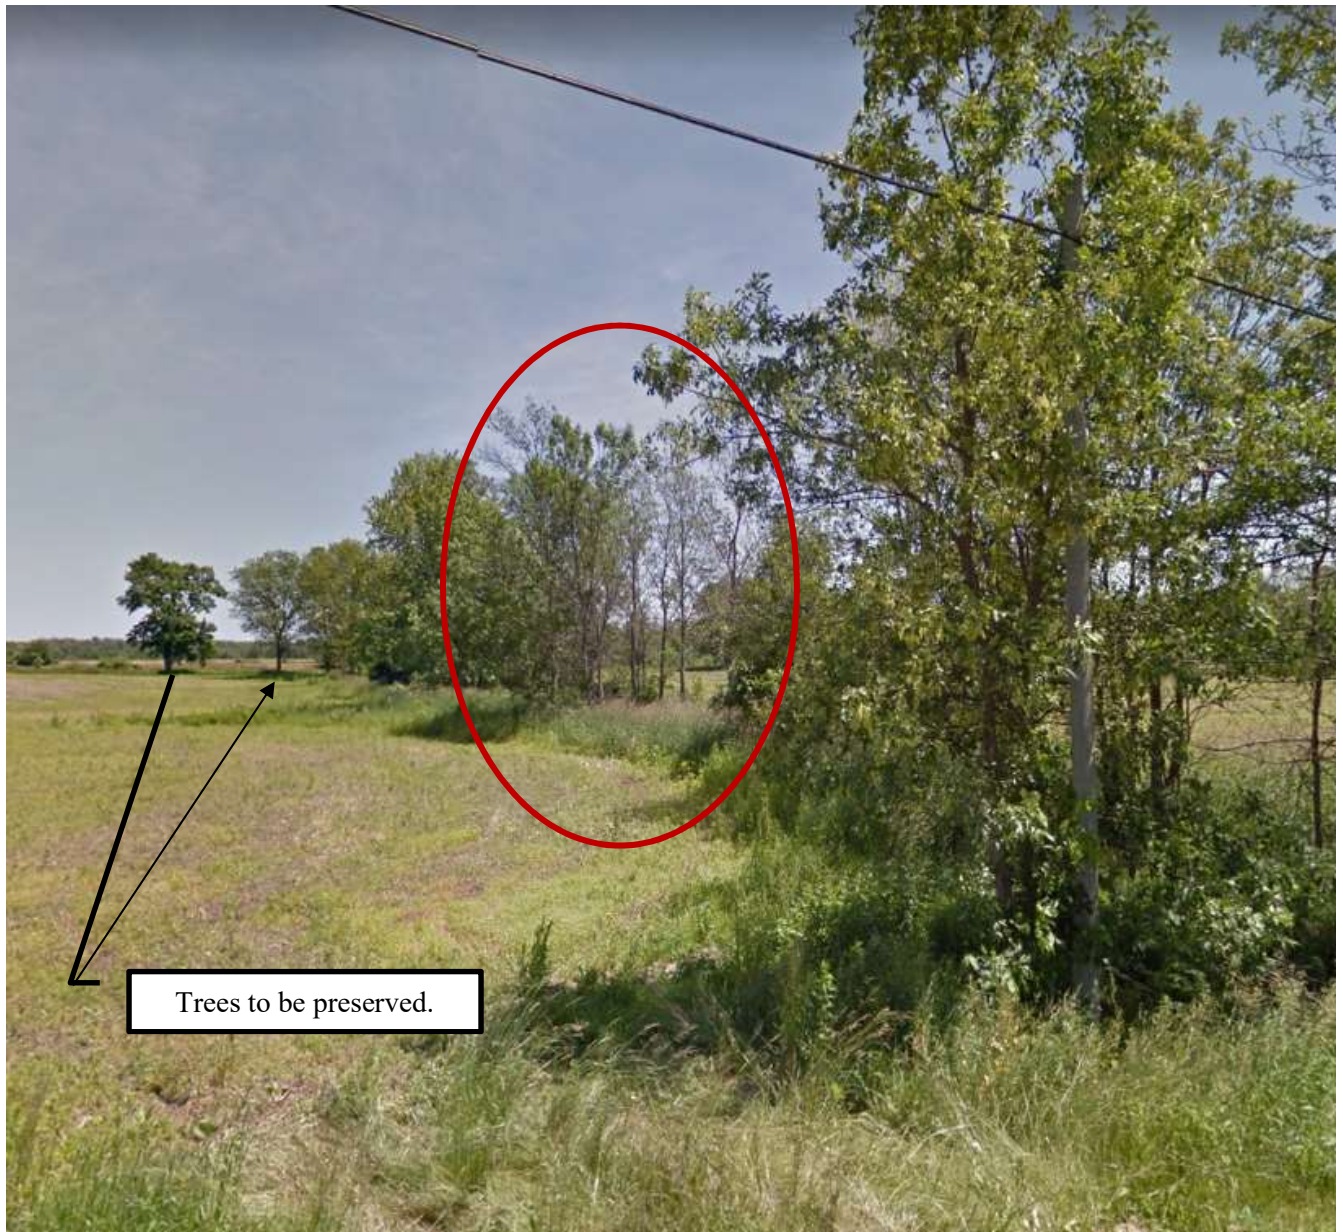
**Figure 9 Wignell Drain Improvements with selective tree removal**

The presence of existing trees on an existing drain does not require a clear cut approach to improving the function of the drain. Trees can be selectively removed to achieve a drain benefit, such as the case with the lower reach of the Wignell drain at Lorraine Road.

Individual trees, as shown in Figure 9, that are currently healthy and with a good expectation for continued good health should be preserved and protected during construction. Trees that group both side of the drain and create an obstruction to flow are to be removed, (red circle in Figure 9).

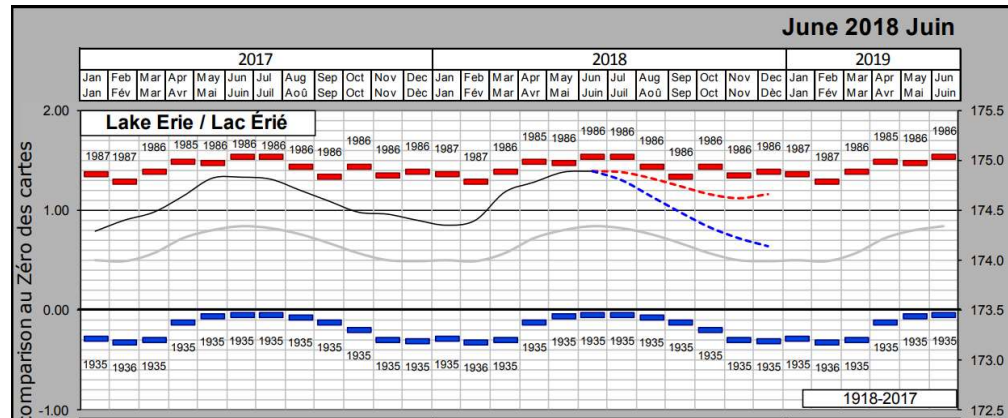
From the F&O Government of Canada Water Level bulletin for June 2018, the mean for month of June, 2018 was reported as 174.89m. This is significantly higher than the Yearly average, + 0.74m above average.

**Figure 17 Lake Erie Water Level GC Hydrographic Bulletin, June 2018**  
The chart shows that for the past two years, water levels are 0.45m above average conditions. Adding wave set up to this further influences the lower reach of the Wignell Drain including Port Colborne Drain and Michener Drain.

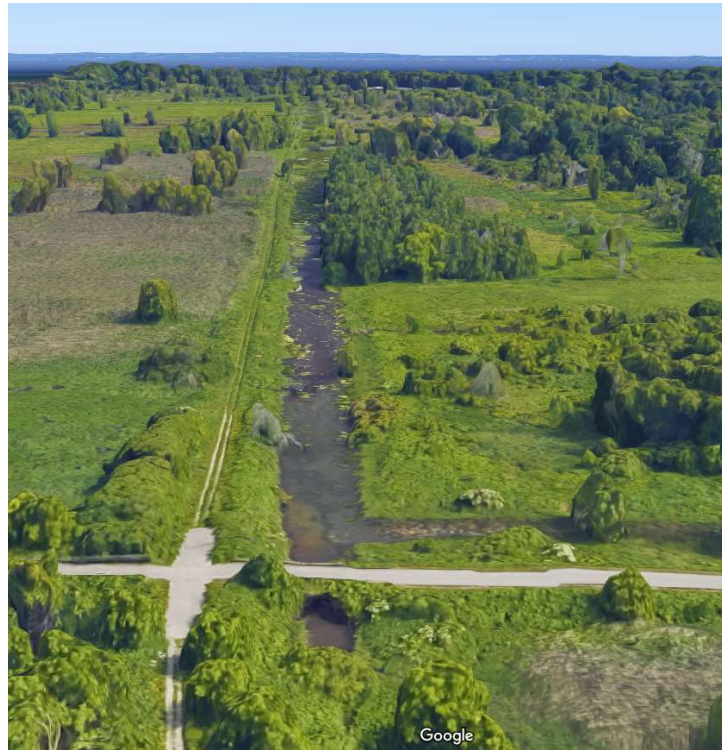
**Figure 18 Wignell @ Friendship Trail looking South**

Segment 1 as seen from Google shows the static water level in the following figure looking South from above the Friendship trail.

The static water is undesirable but directly influenced by the lake level. There are opportunities to control the difference water elevations by restricting the flow back from the Lake and pumping out from the land side. This is done in many locations in Ontario to achieve positive drainage

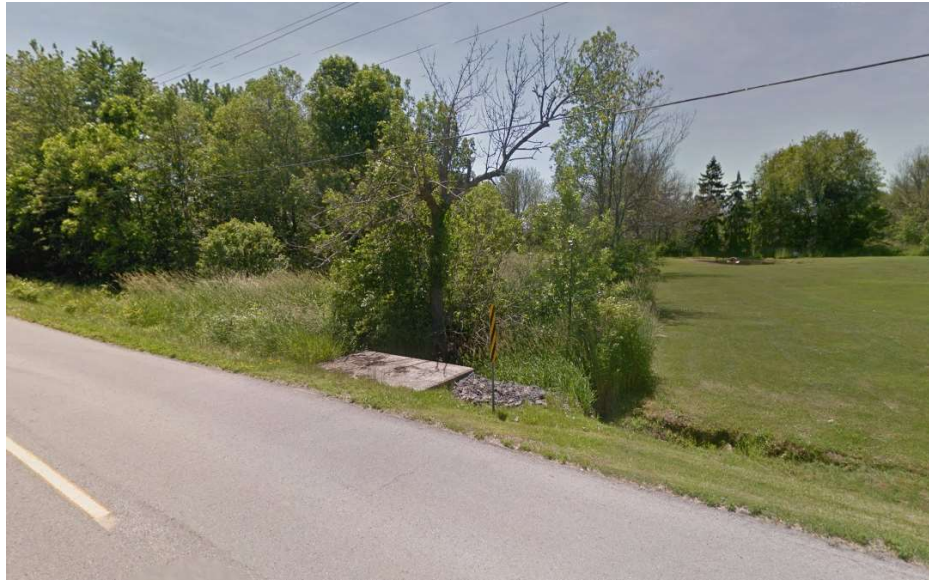
**Figure 19 Wignell @ Lorraine Rd. looking Downstream**

**Segment 2** is the transition from the water surface profile gradeline ditch to a flowing graded ditch. The transition point would appear to be the road crossing at Lorraine Rd. The following figures show the upstream and downstream views

What's visible is the existing trees and other vegetation that occupies the drain top width. Trees within the top of bank to top of bank create obstructions to flows. Also evident is the cultivation up to the edge of the drain without the presence of a buffer zone north side upstream.

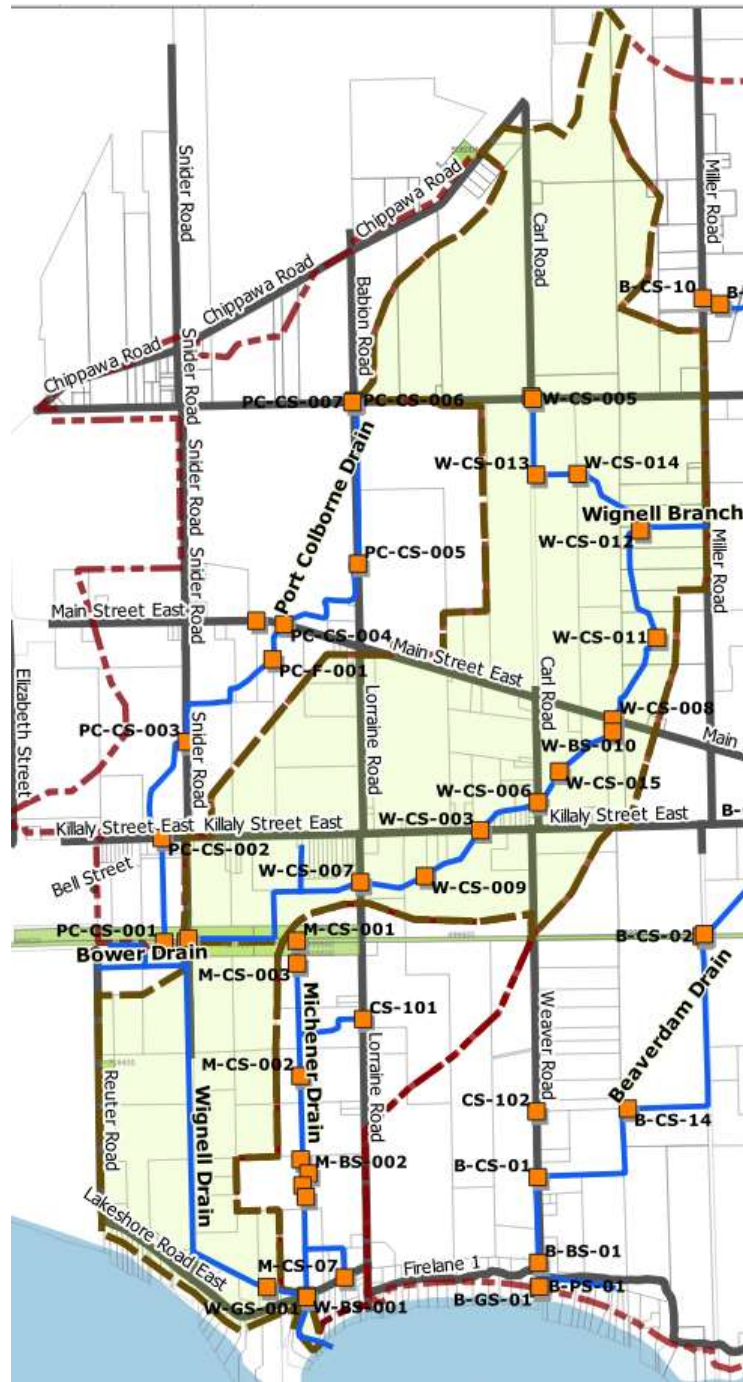
Figure 22 Bridge and Culvert Drain Structures

There are 15 crossing on the main drain consisting of bridges, culverts or flow controls. The crossings are shown in the following figure and are listed in the following Table. A larger map showing crossing with labels for cross reference is included in Appendix B.

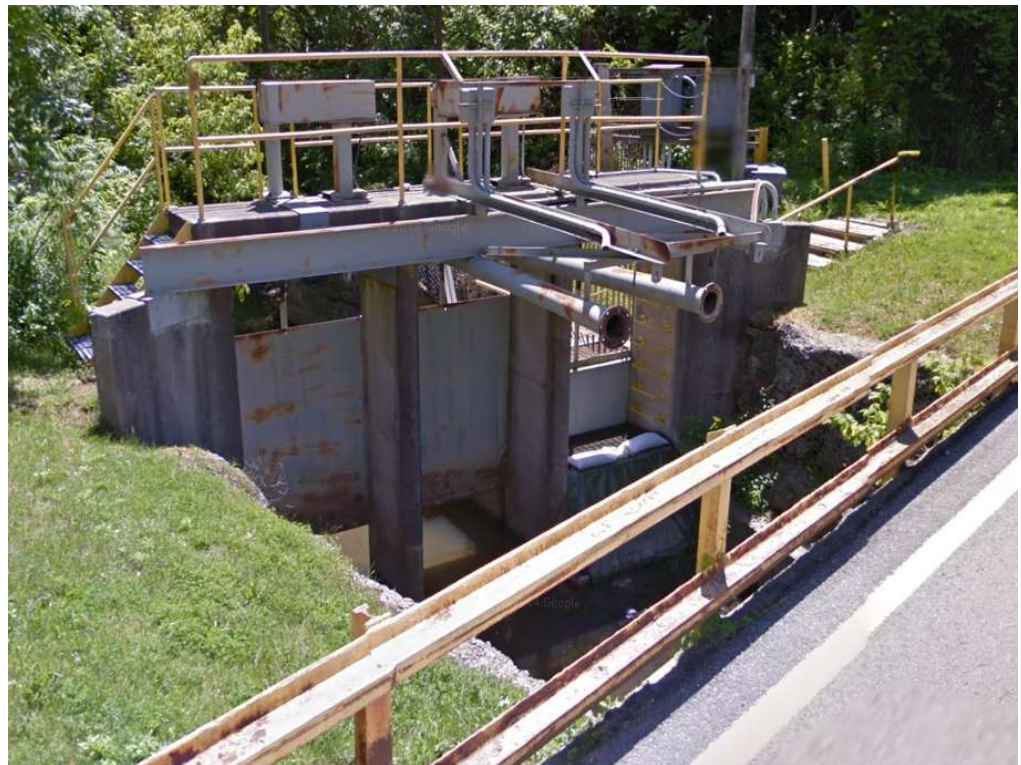
**Figure 23 Wignell Control Structure - 01**

Wignell Drain includes a control structure located immediately south of Lakeshore Rd. East. Identified on the maps as W-GS-001.

The control structure at the outlet of the Wignell/Michener Drain consists of a concrete dam with three steel sluice gates with gate actuators, a bypass well formerly installed with a well pump but not currently in operation, an emergency bypass river pump mount and associated piping. The well pump was installed in a small pump house mounted directly above the well structure but is not currently operational.

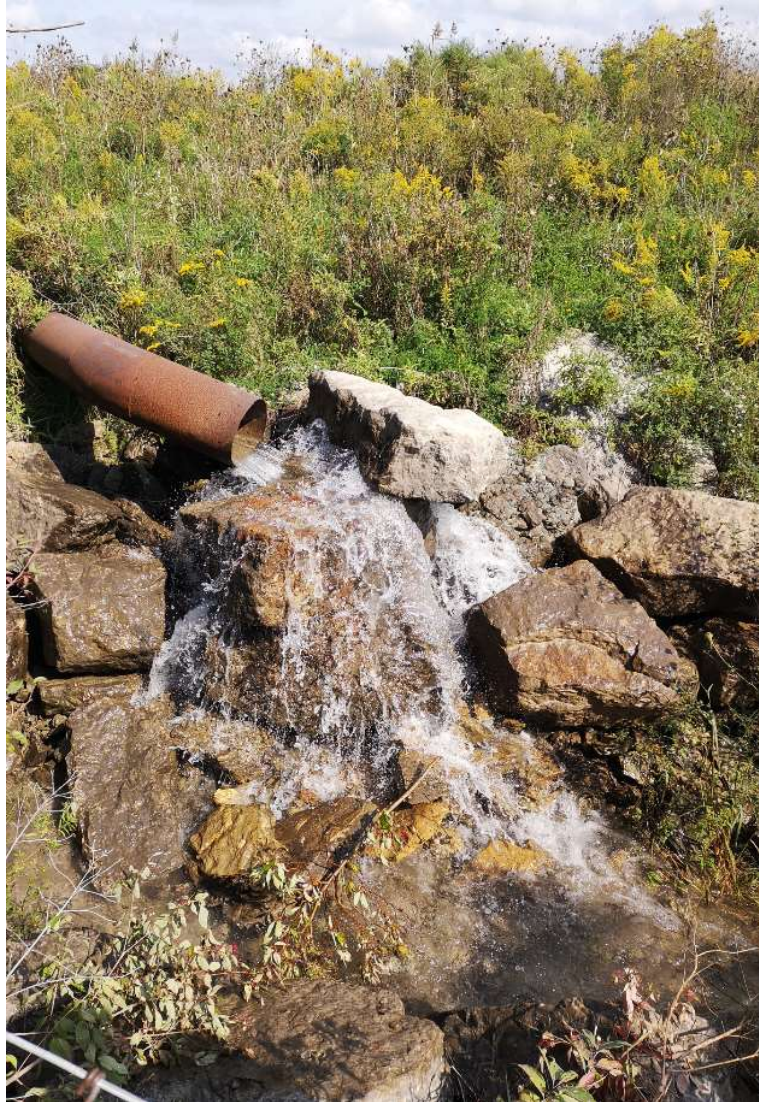
**Figure 24 West Side PC Quarry Pump Discharge - Sept 19**

The quarry is pumping water that has passed through the upland clay soils and the clay is known to suspend in the water column for long periods of time, (colloidal property of clay). Discharge of the impounded water in the quarries is monitored and the picture taken on September 19, 2018 shows that the discharge from the quarry is quite clear.

The picture shows a clear discharge, and it was related anecdotally that runoff into the quarry is influenced by the clay soil and runoff quality from both the drain without a quarry and the runoff from the quarry are similar. The quarry acts as a large detention basin allowing some sediment to settle out of the runoff water but the clay soil contribution is long duration for colour in the water, which is not necessarily an indicator of poor quality.

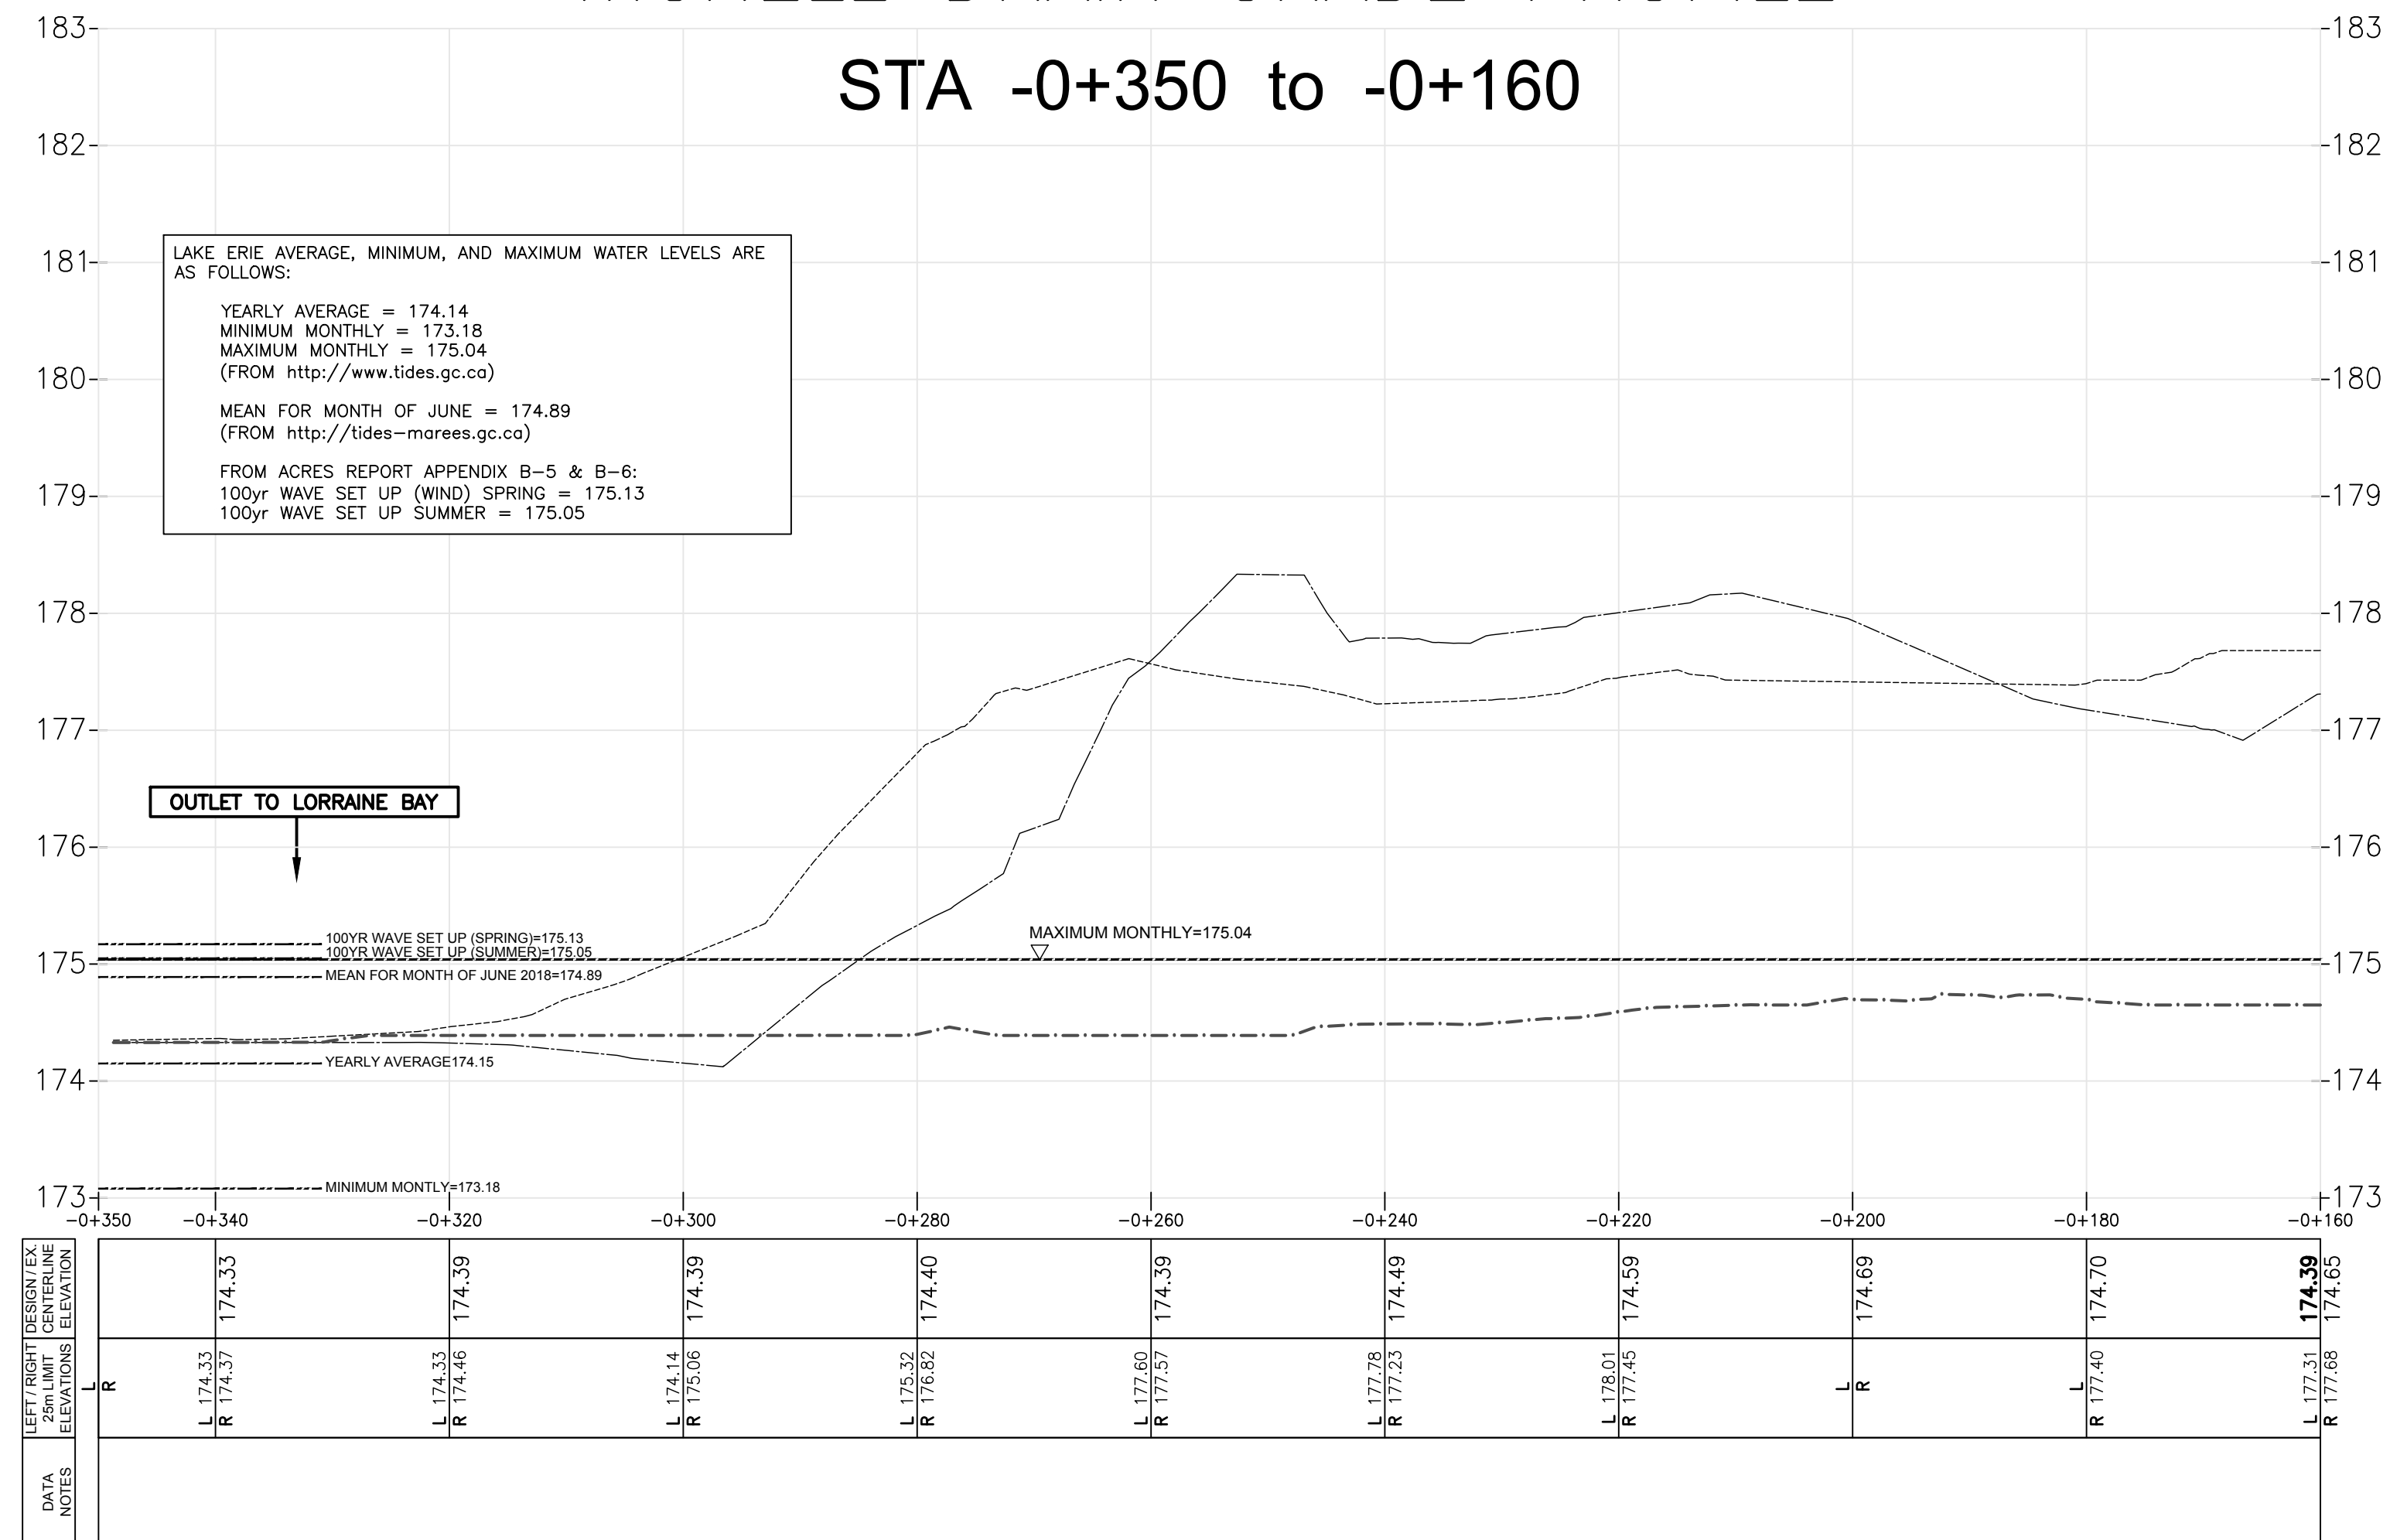
## STA -0+350 to -0+160

# WIGNELL DRAIN GRADE PROFILE

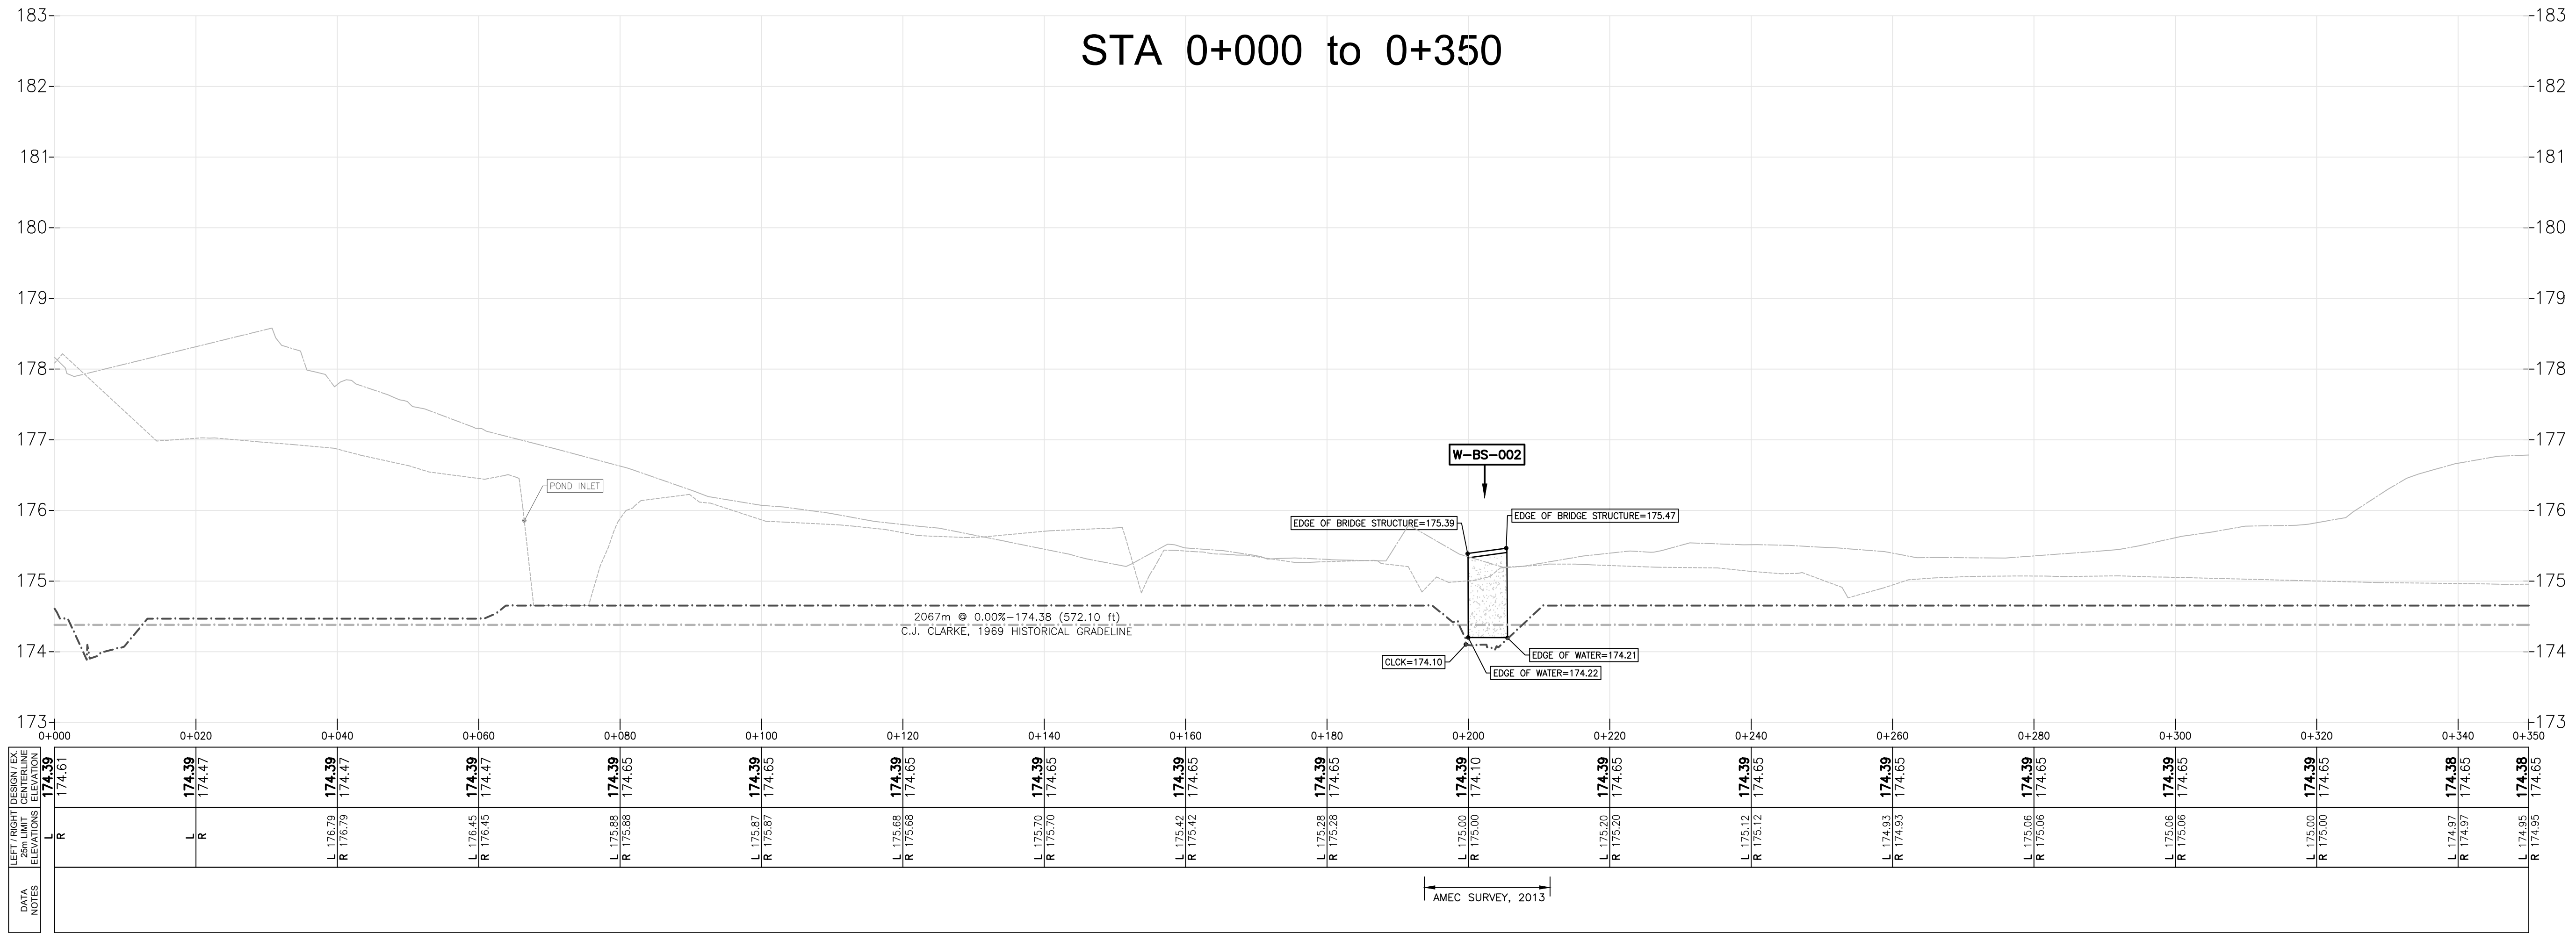
## STA 0+000 to 0+350

# WIGNELL DRAIN GRADE PROFILE

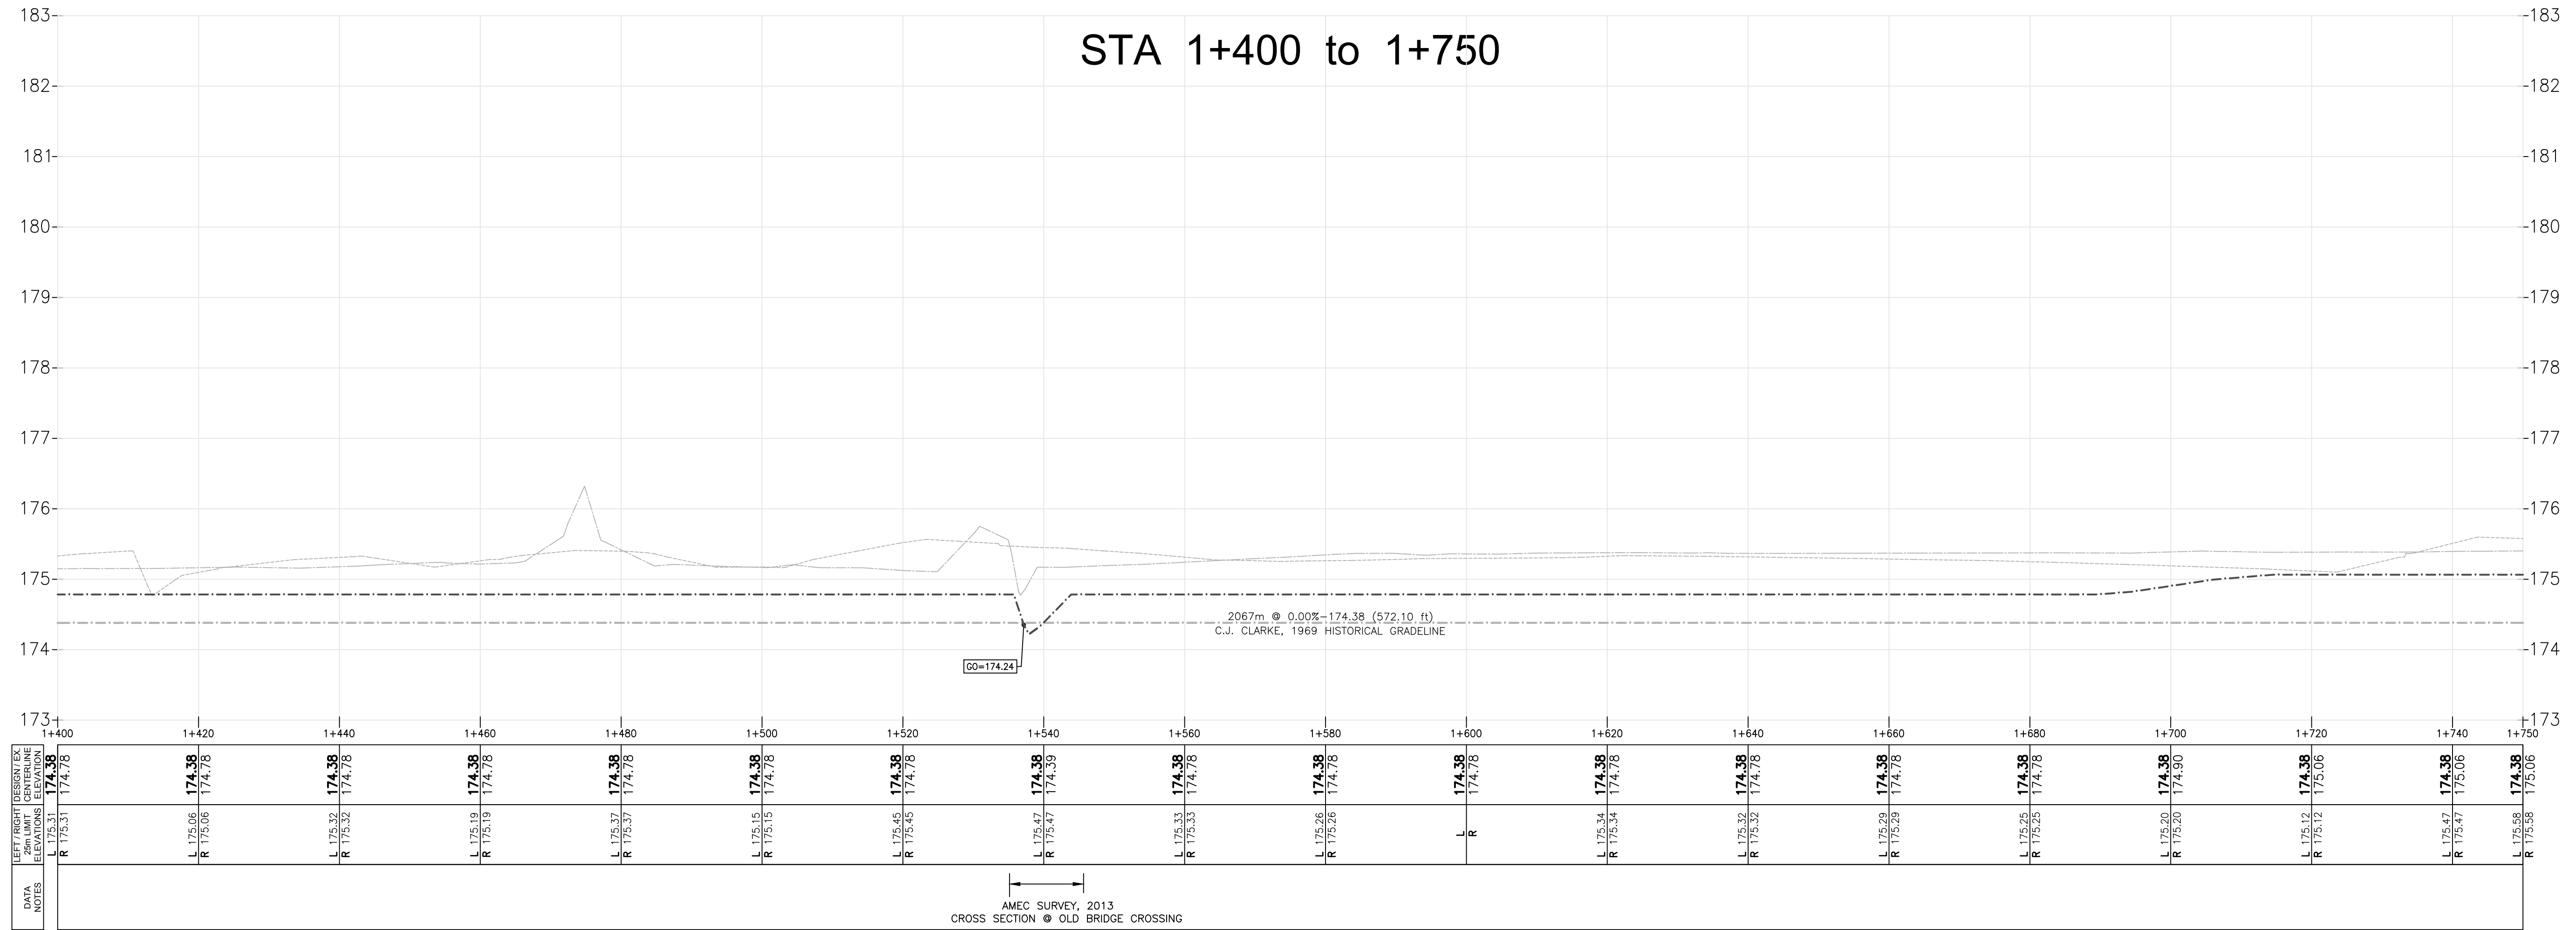
## STA 1+400 to 1+750

# WIGNELL DRAIN GRADE PROFILE

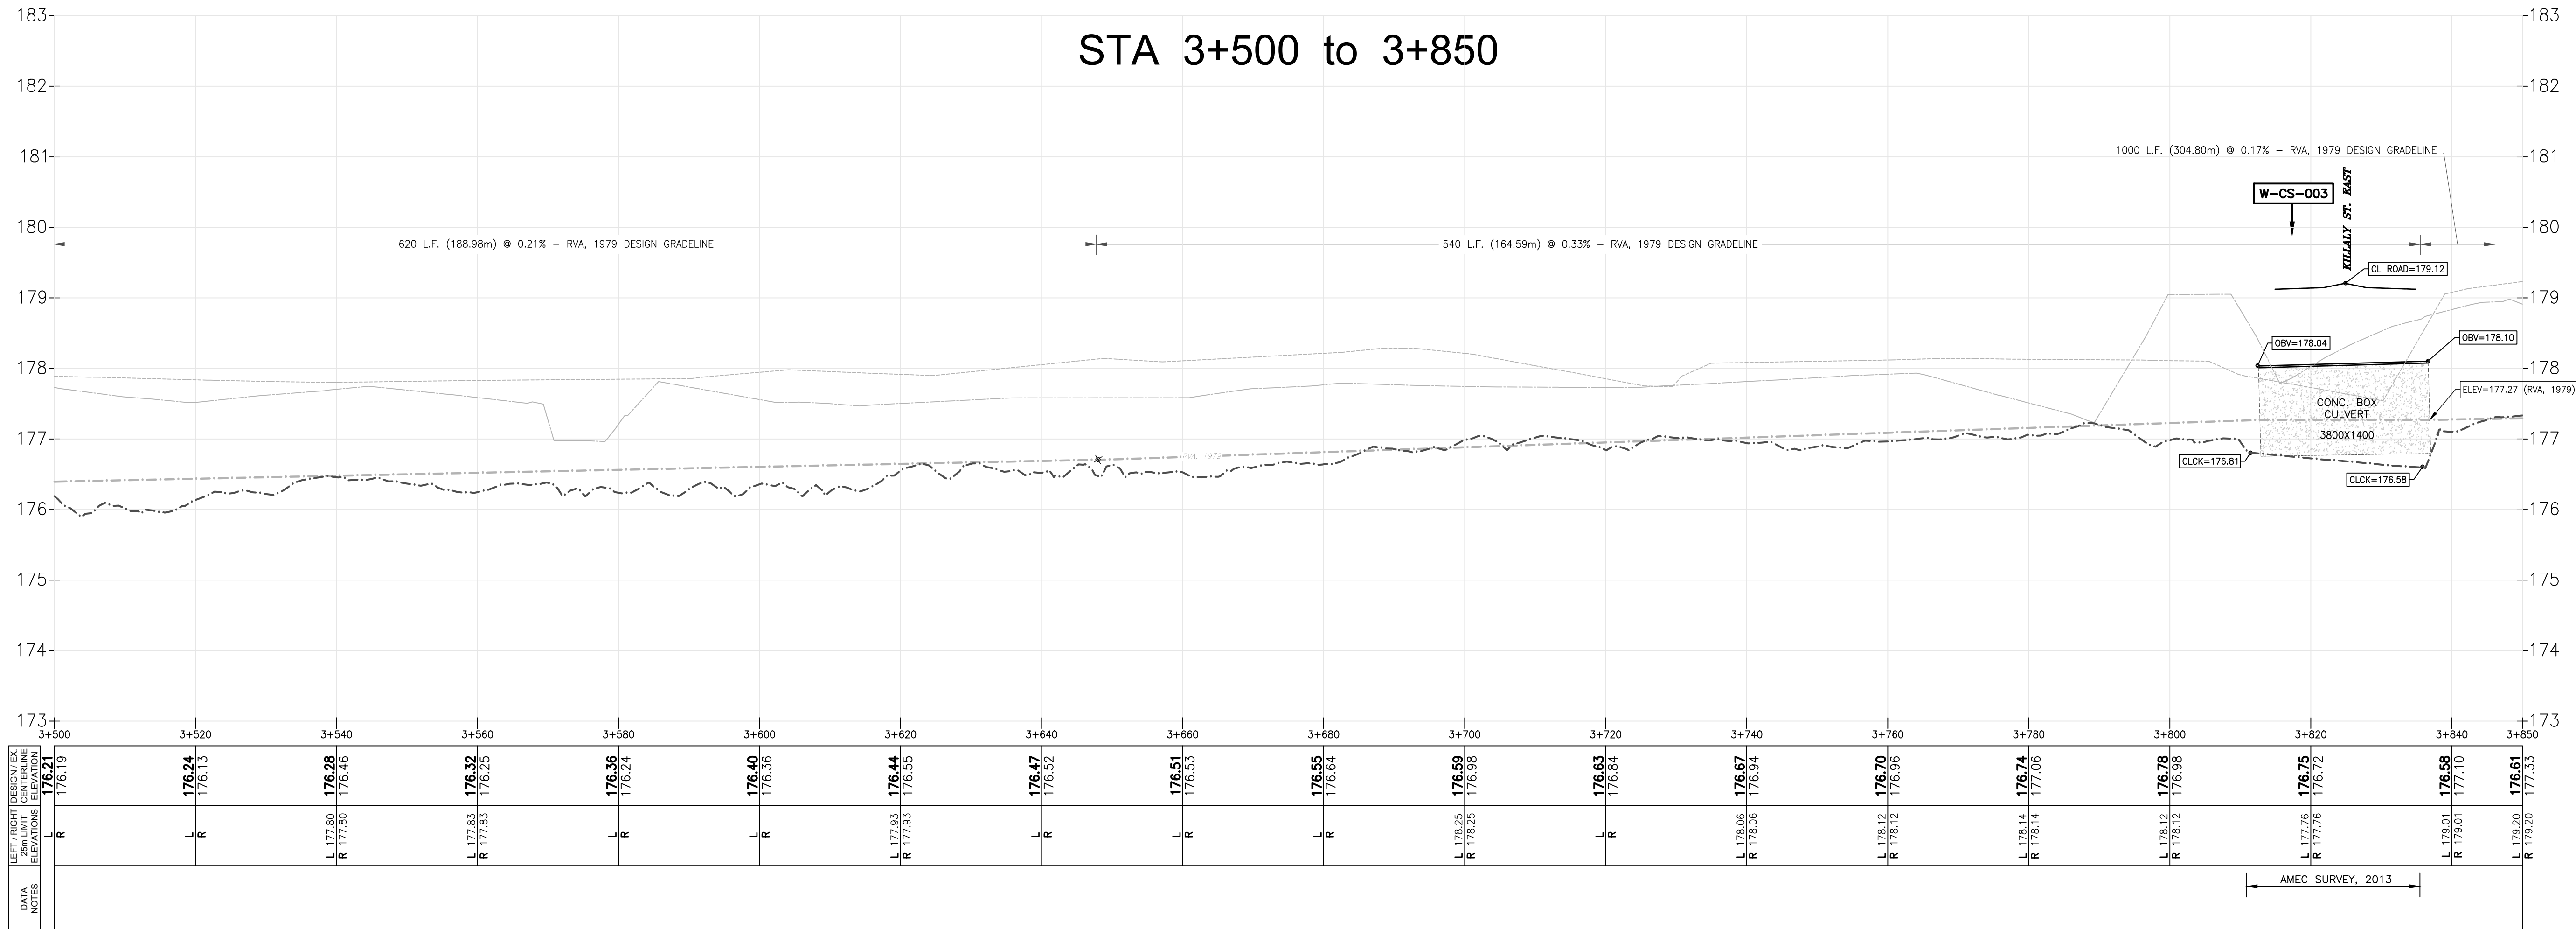
## STA 3+500 to 3+850

# WIGNELL DRAIN GRADE PROFILE
