# **Wignell Drain Stormwater Baseline Report**

Project No: EWB-189999

**EWA Engineering Inc.**

**City of Port Colborne  
Wignell Drain Baseline Report**

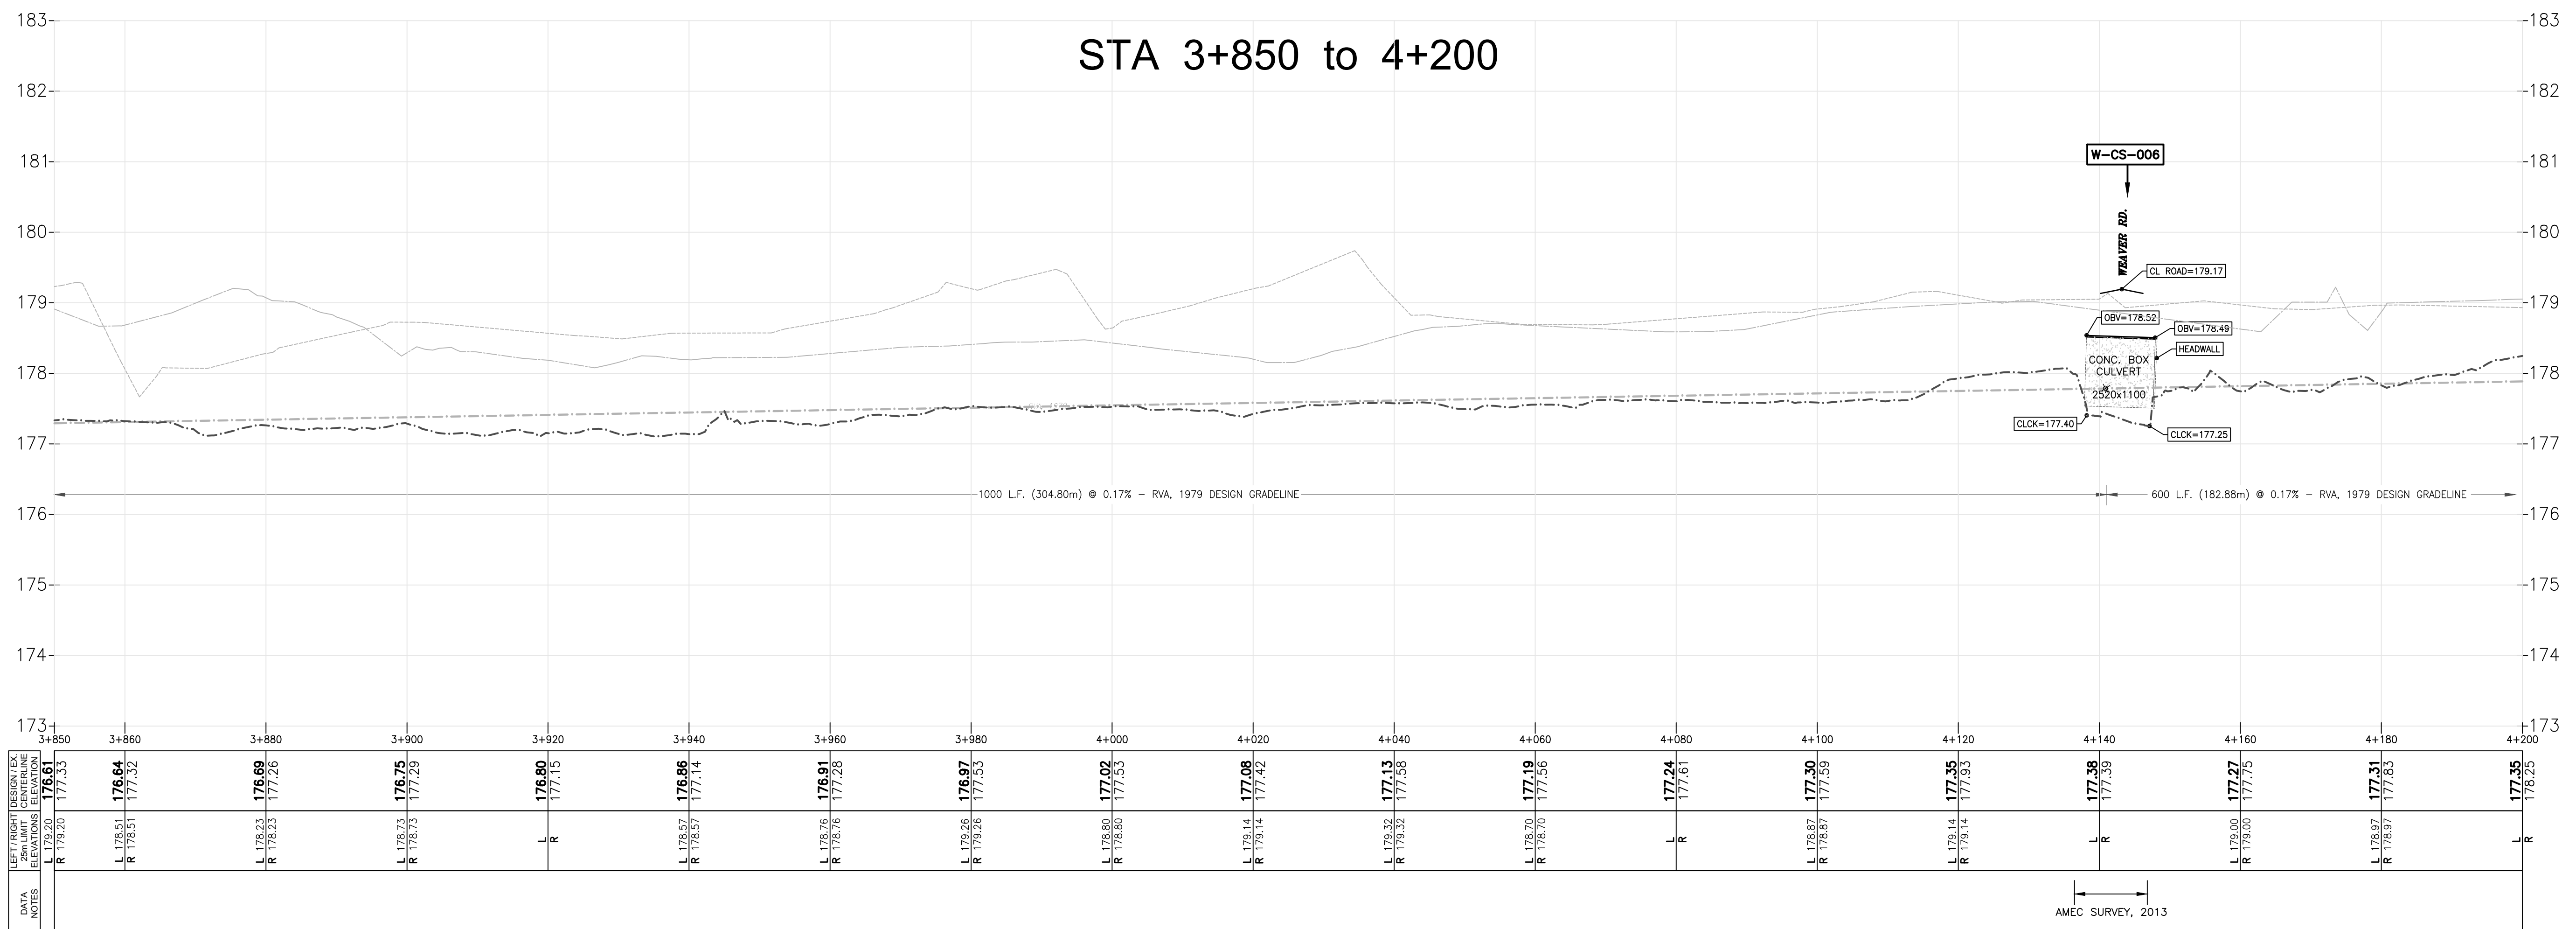
## STA 3+850 to 4+200

# WIGNELL DRAIN GRADE PROFILE

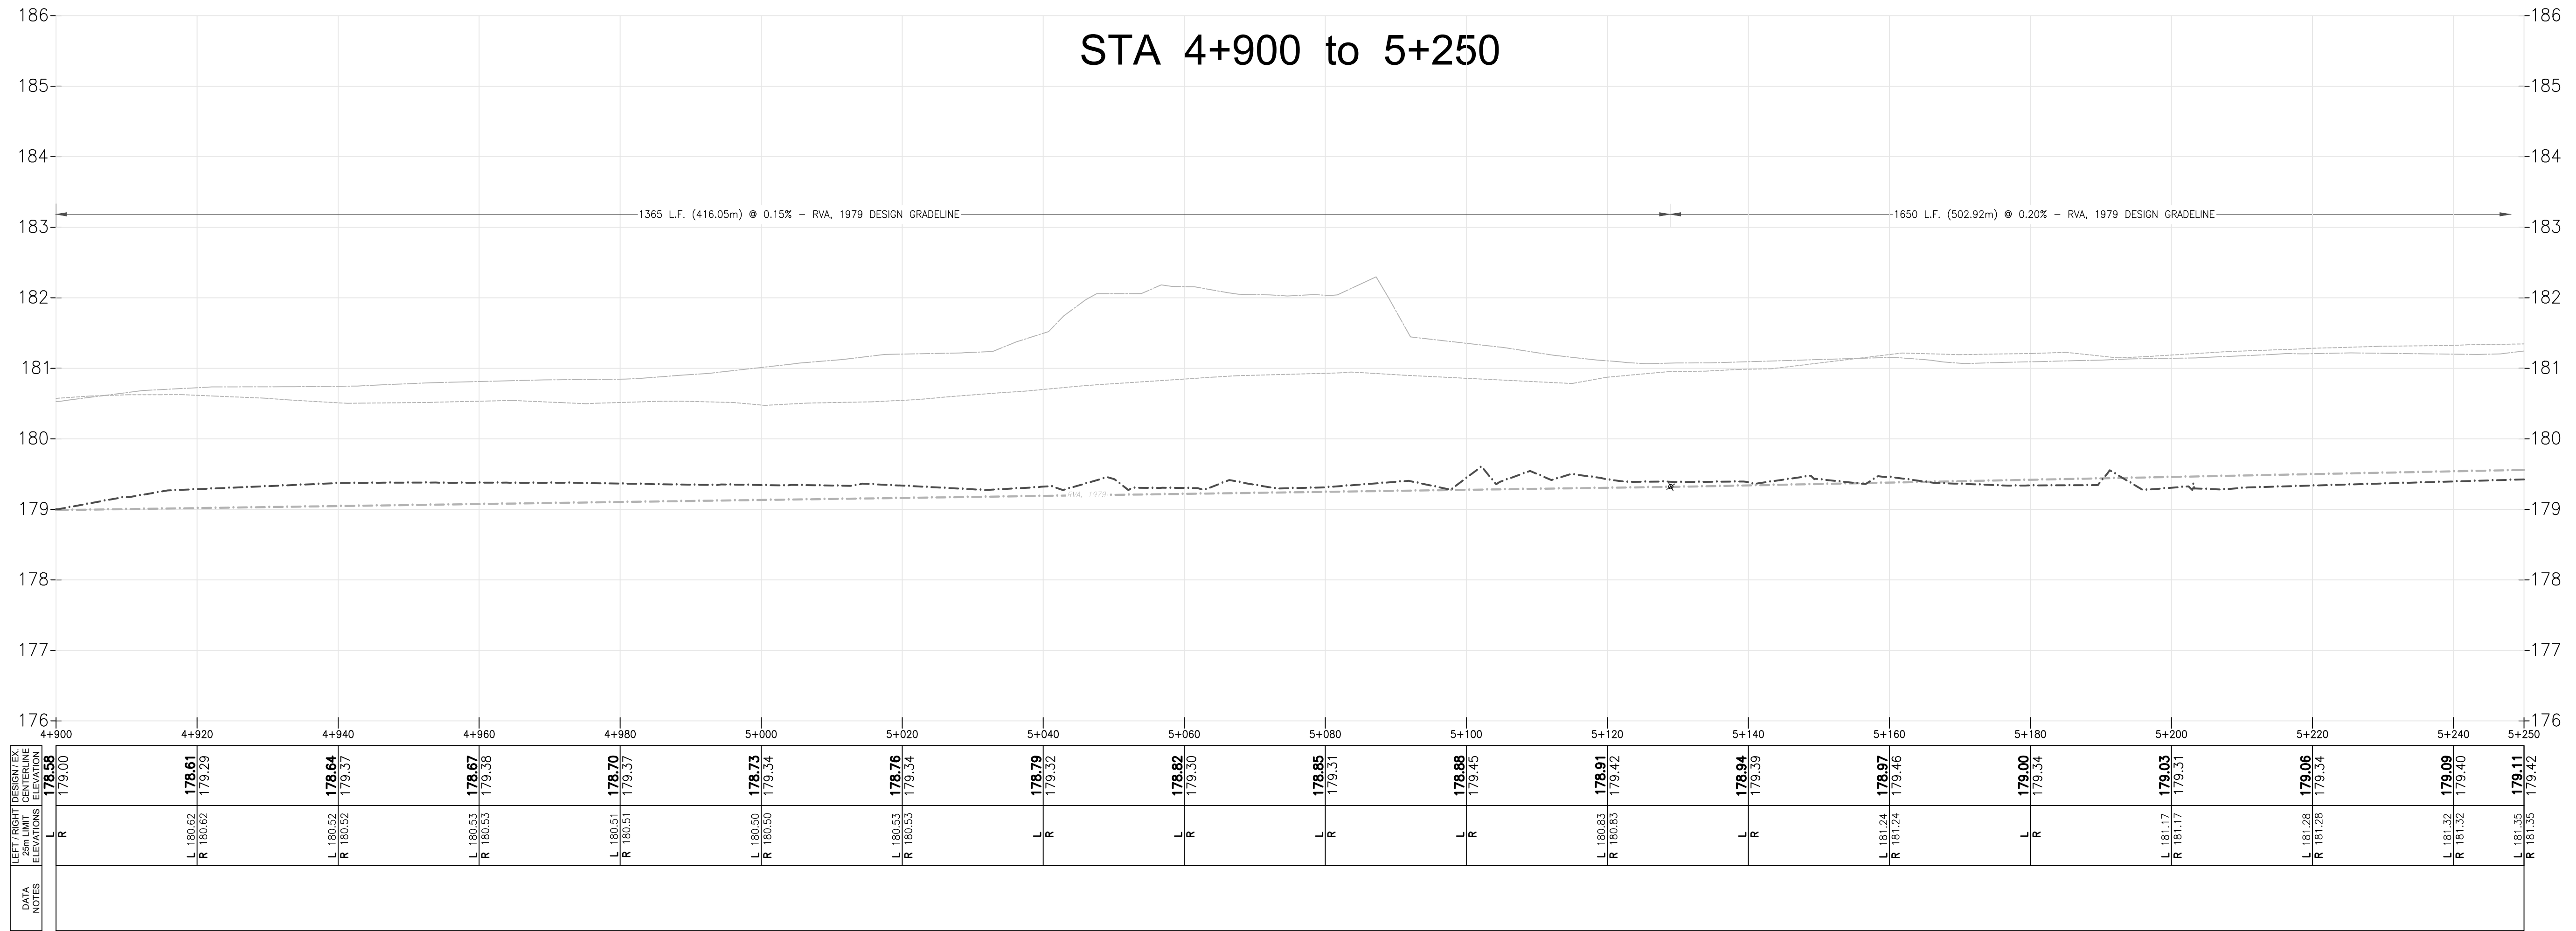
## STA 4+900 to 5+250

# WIGNELL DRAIN GRADE PROFILE

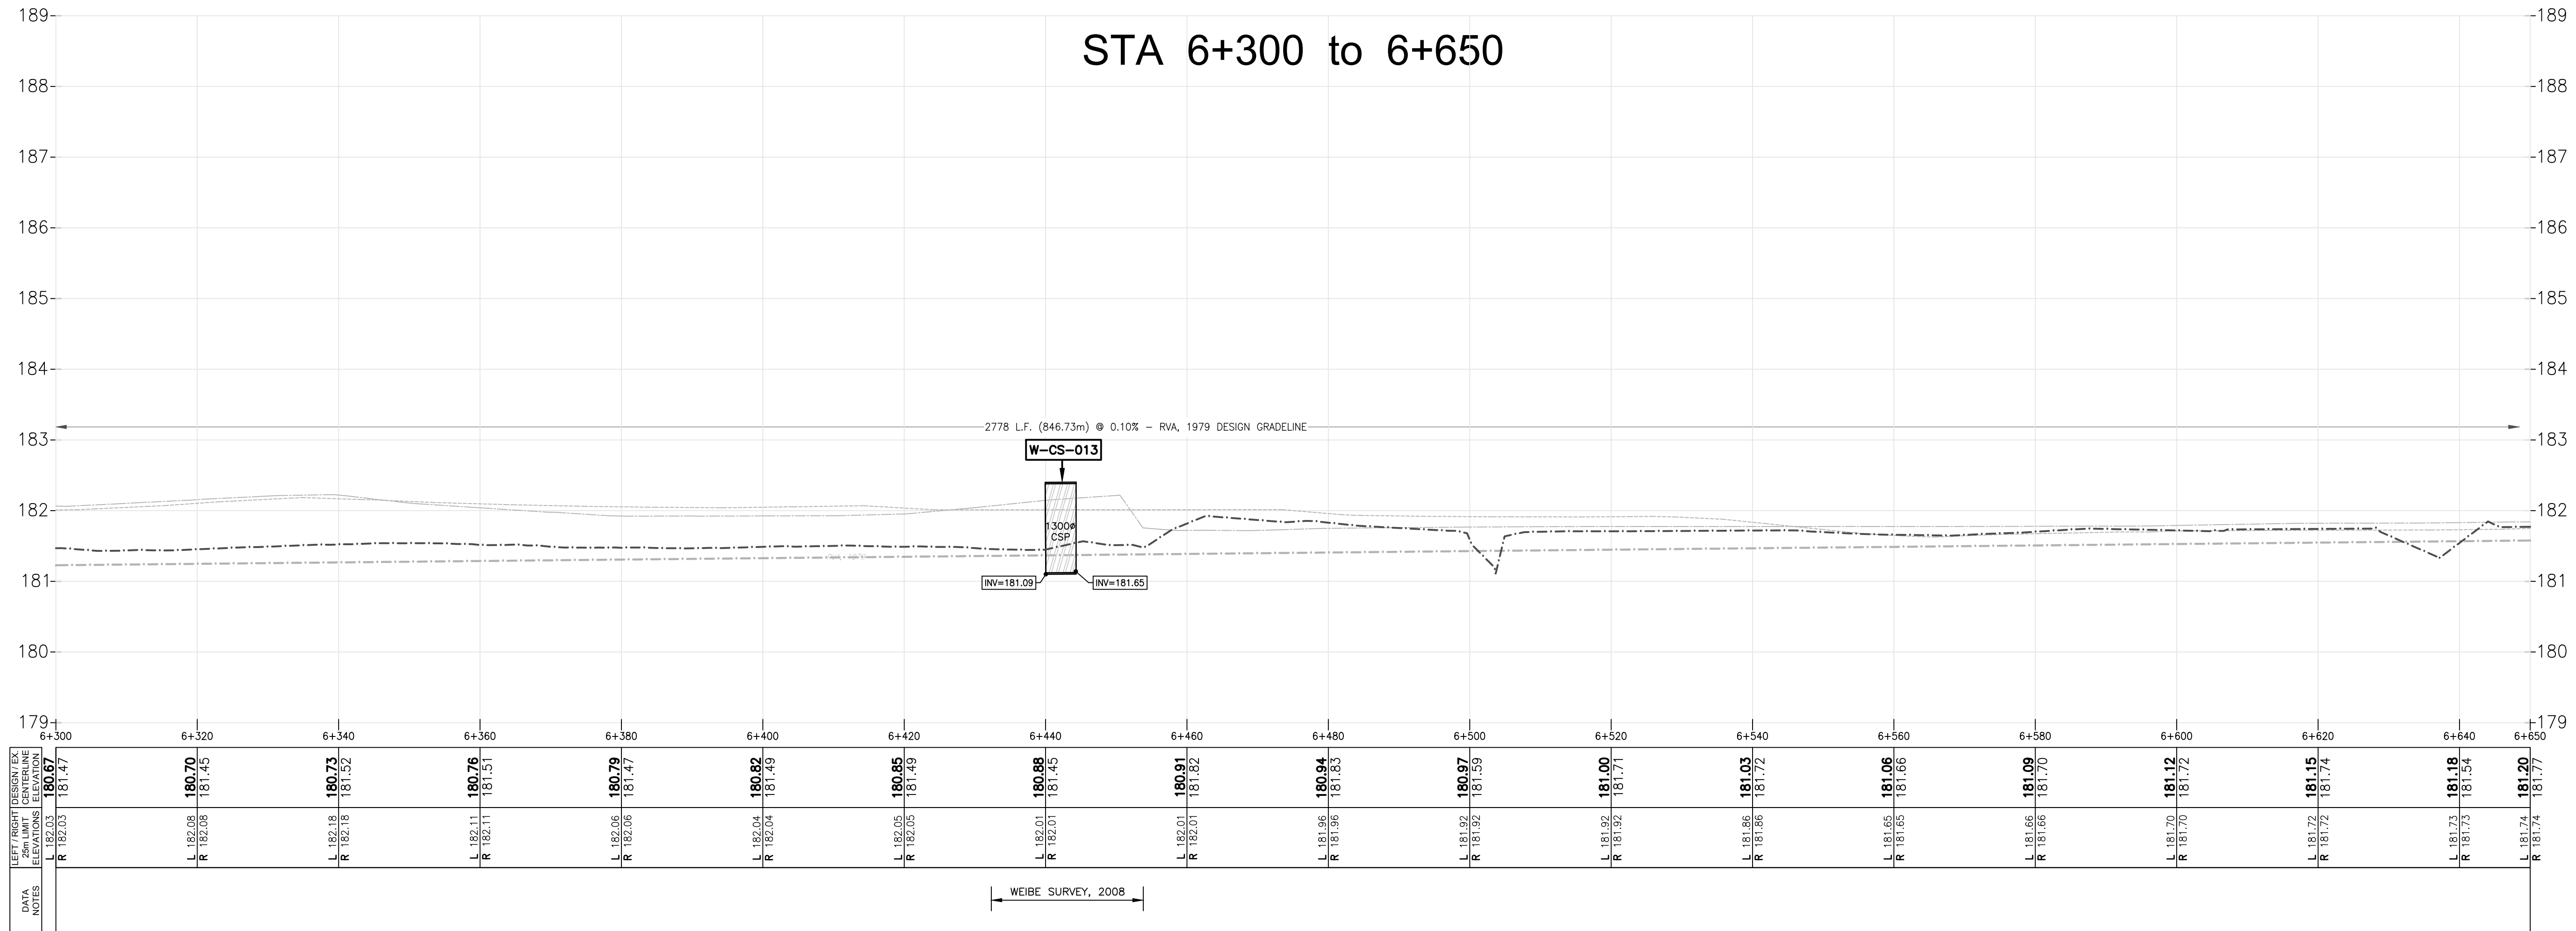
## STA 6+300 to 6+650

# WIGNELL DRAIN GRADE PROFILE

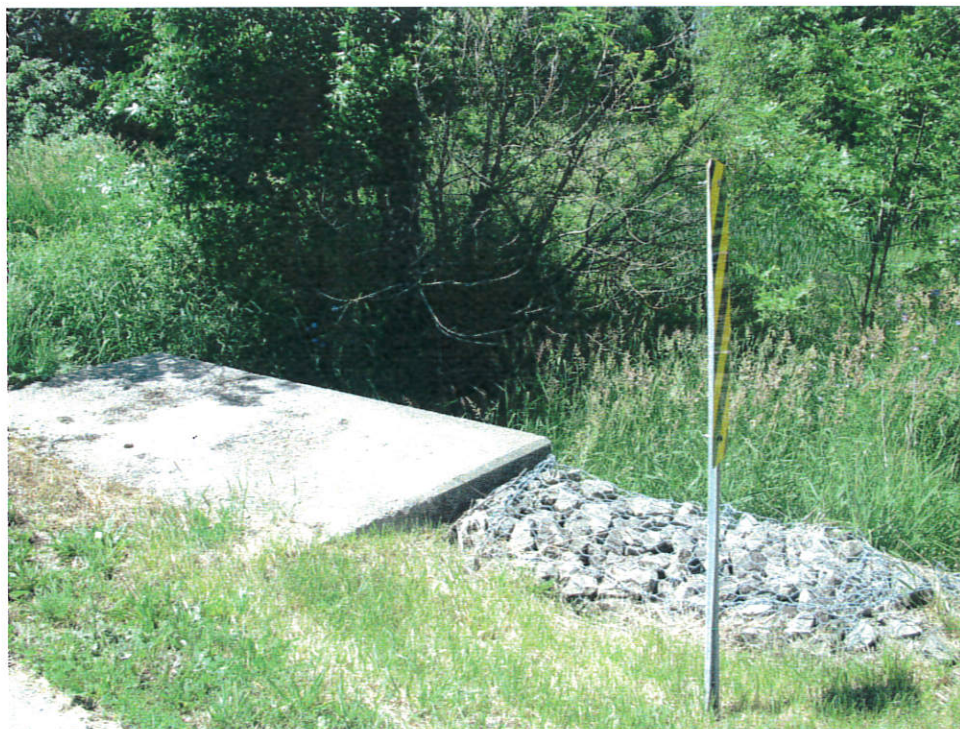
The west end of the structure

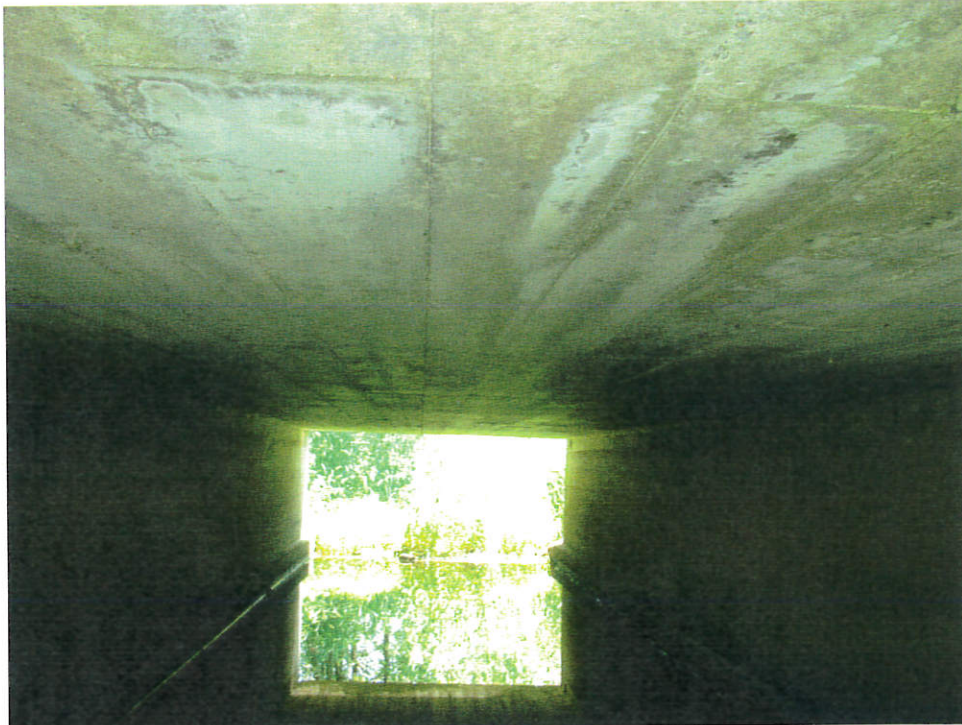
View of the interior of the structure, from the west end

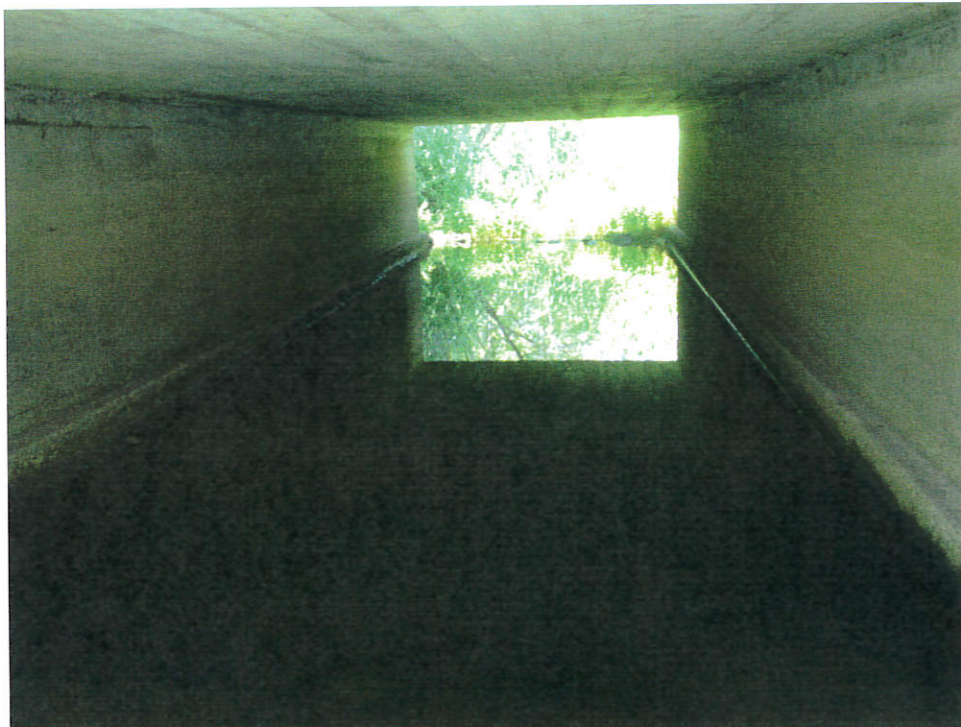
View of the interior of the structure, from the east end

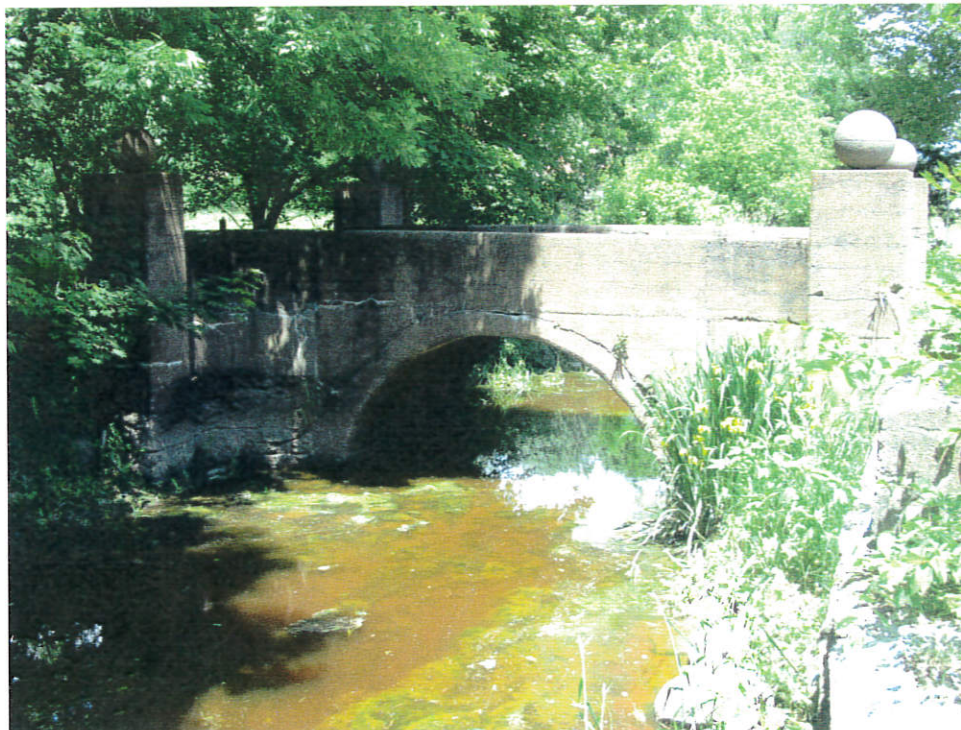
View of the structure, from the south side

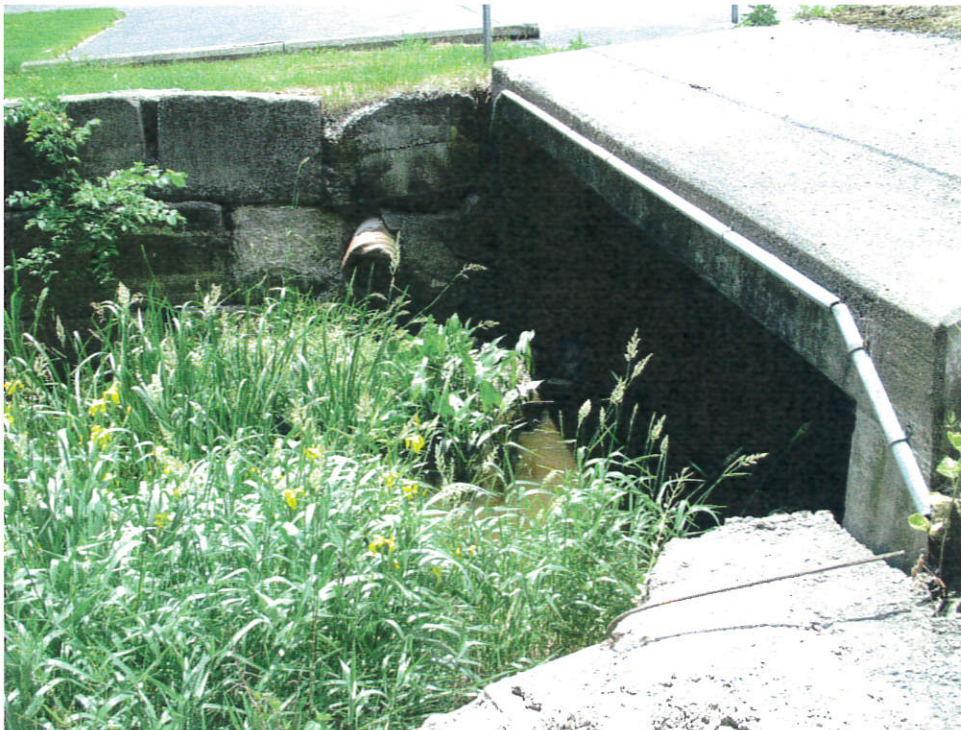
The east end of the structure

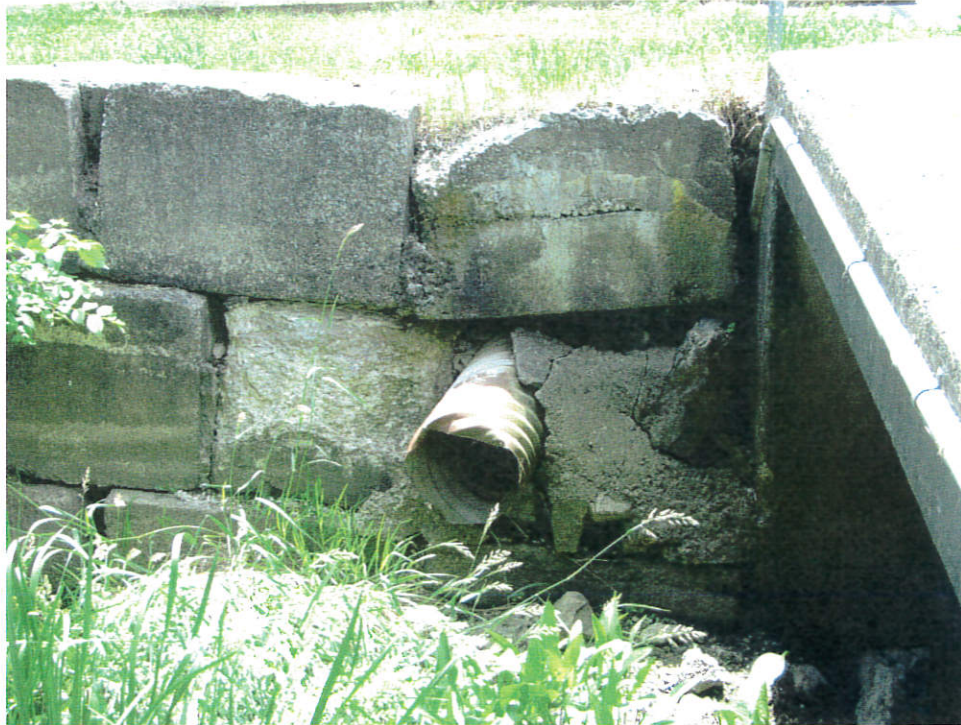
Concrete block retaining wall at the southeast corner of the structure

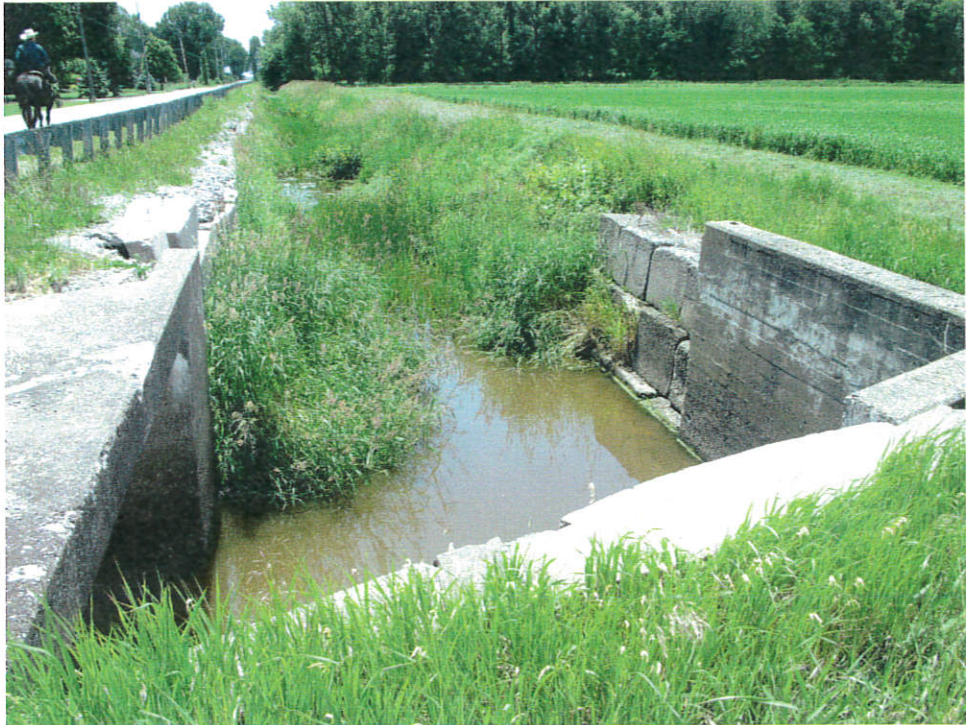
The west end of the structure

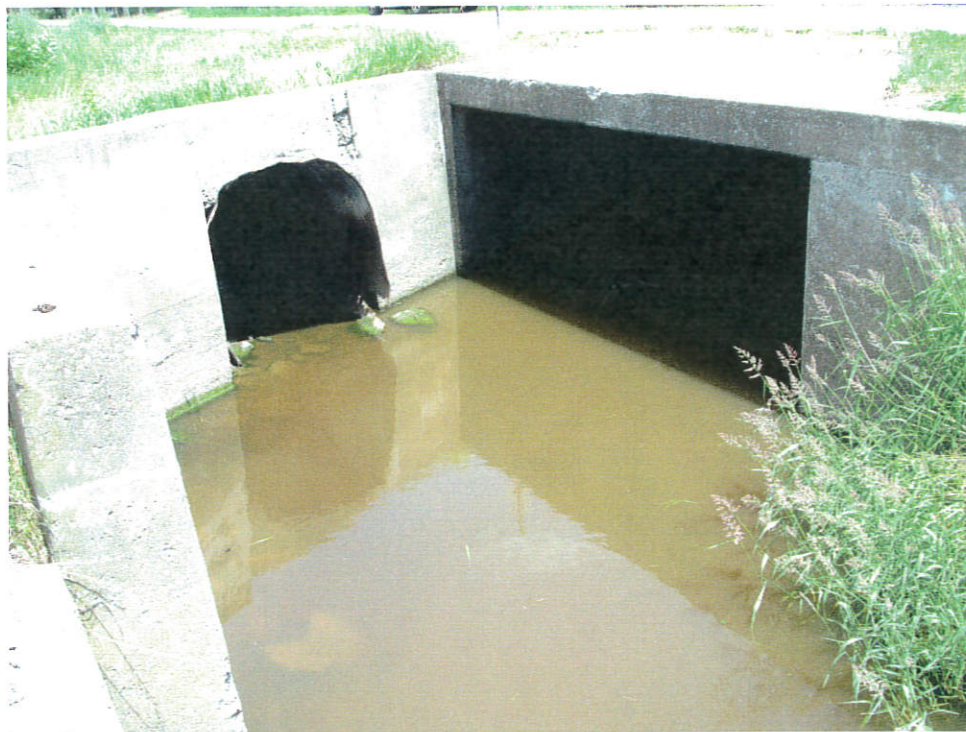
The west end of the structure

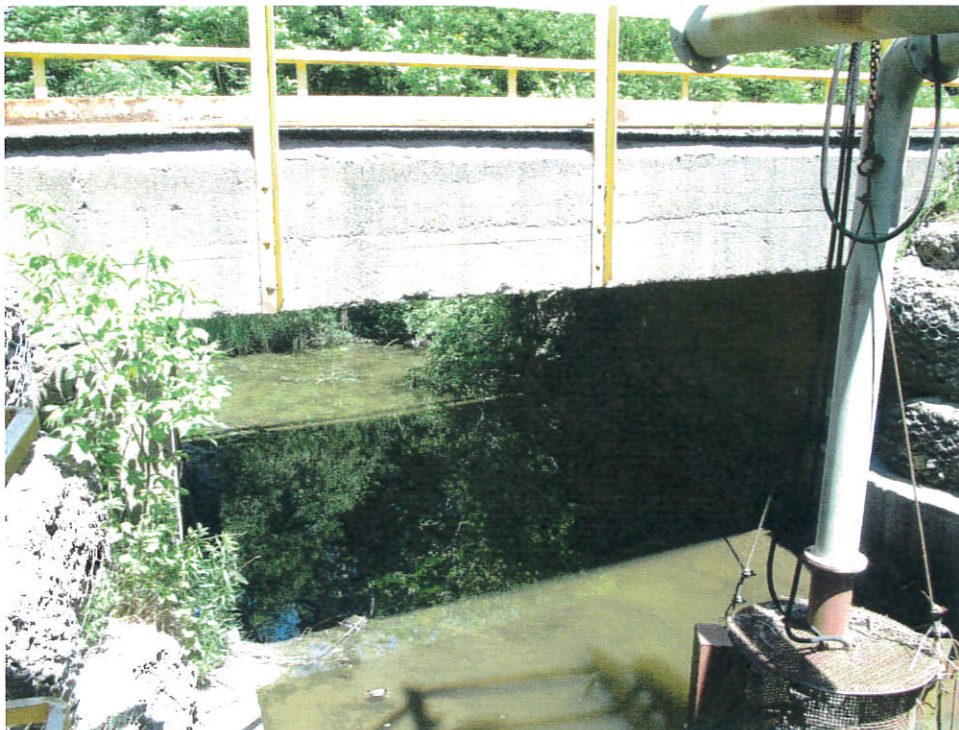
The south side of the structure

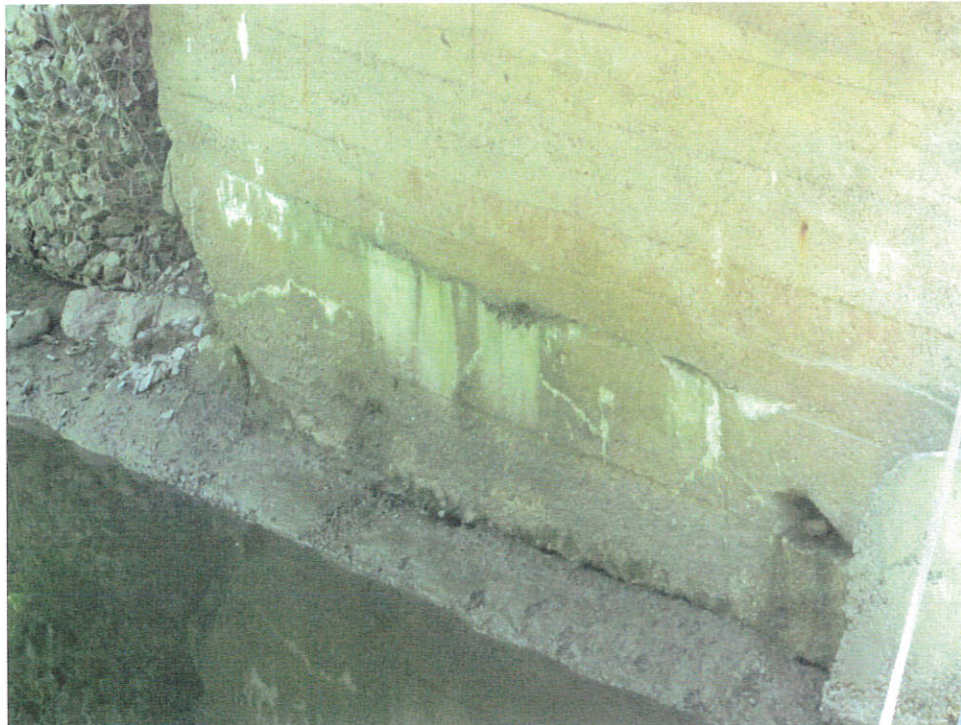
The east wall of the structure

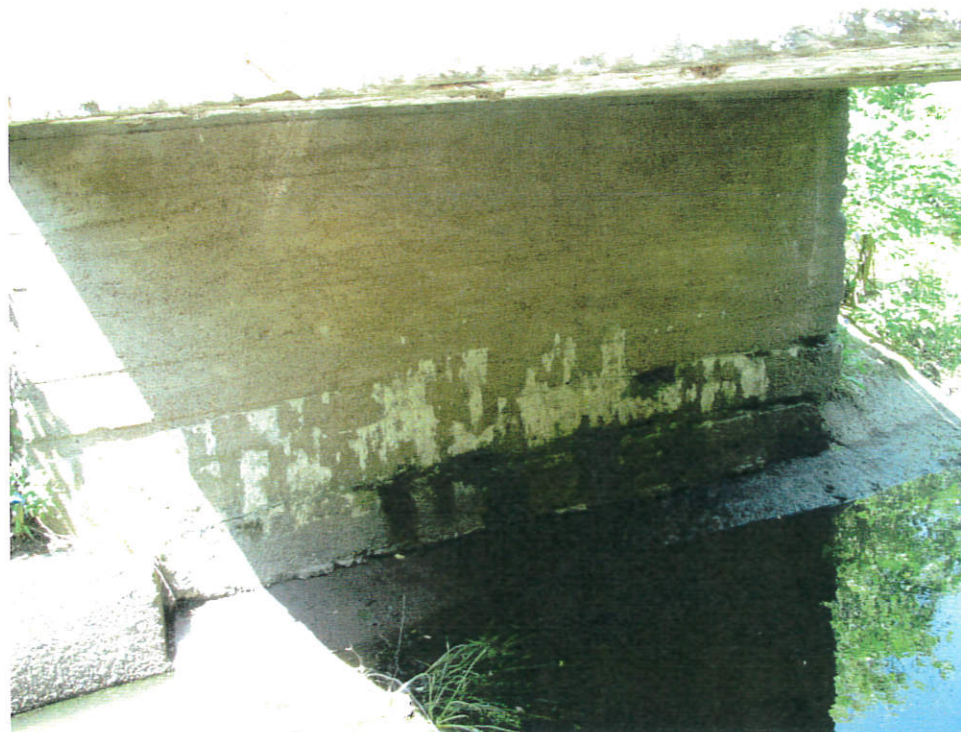
The west wall of the structure

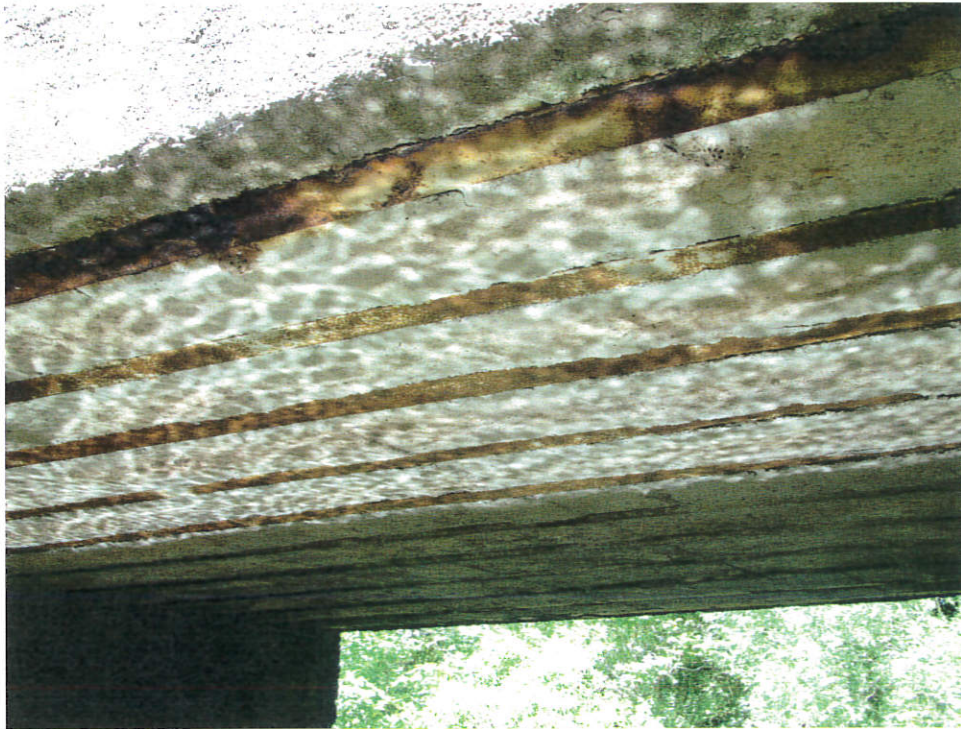
The underside of the structure

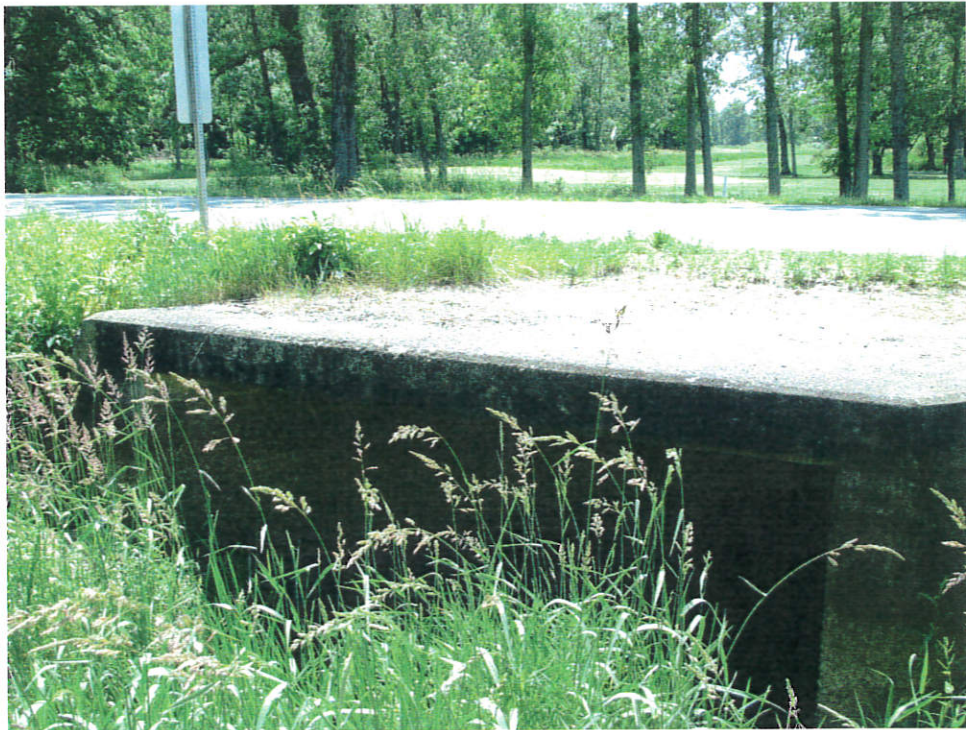
The north end of the structure

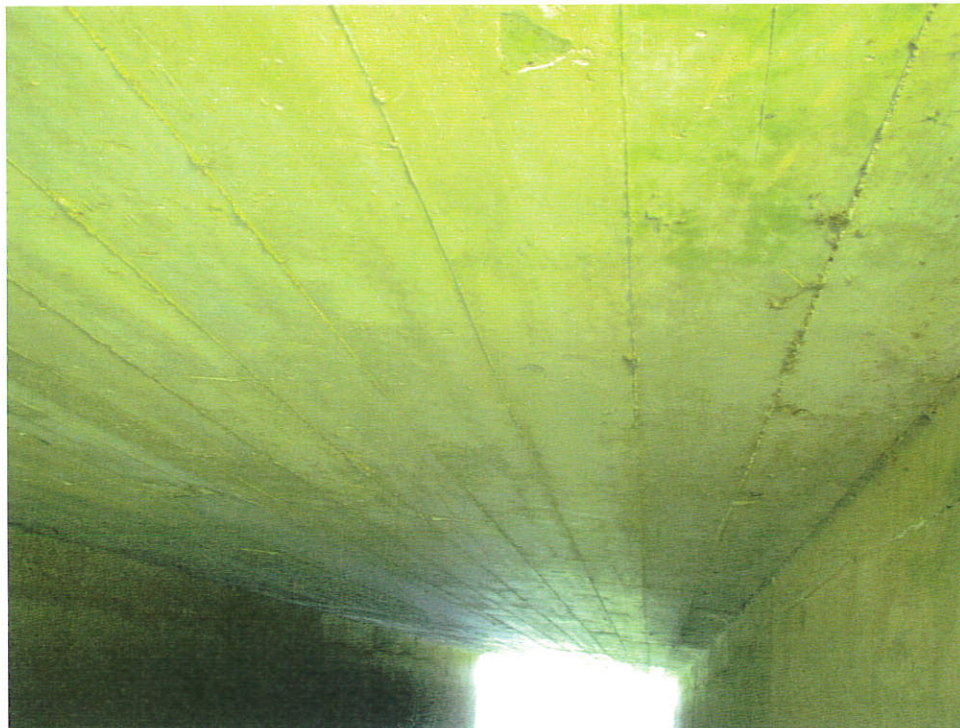
The underside of the structure

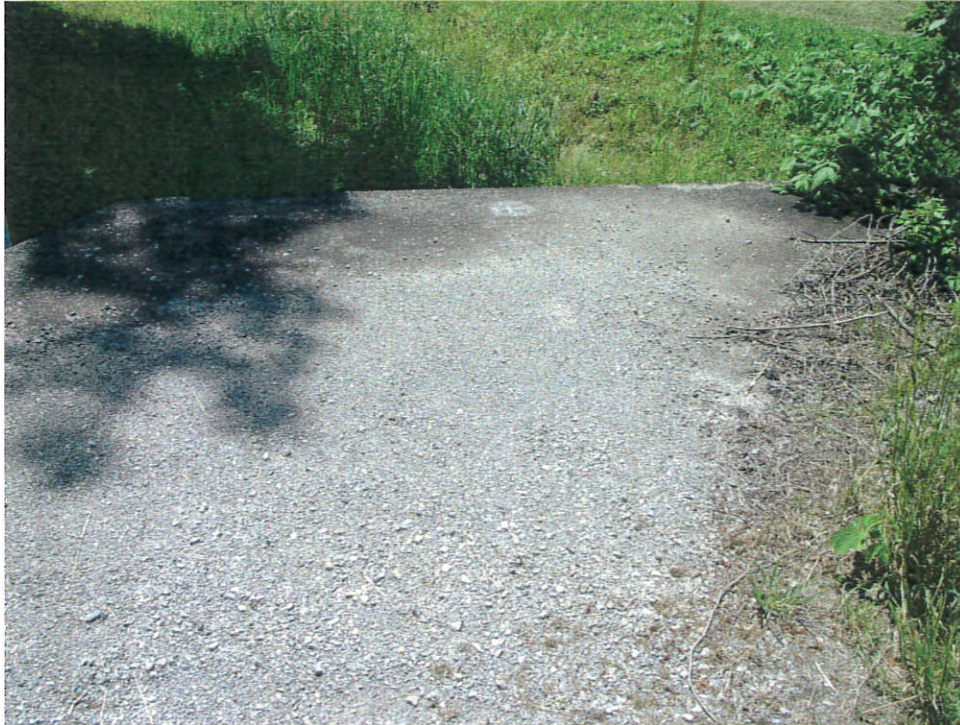
The south end of the structure

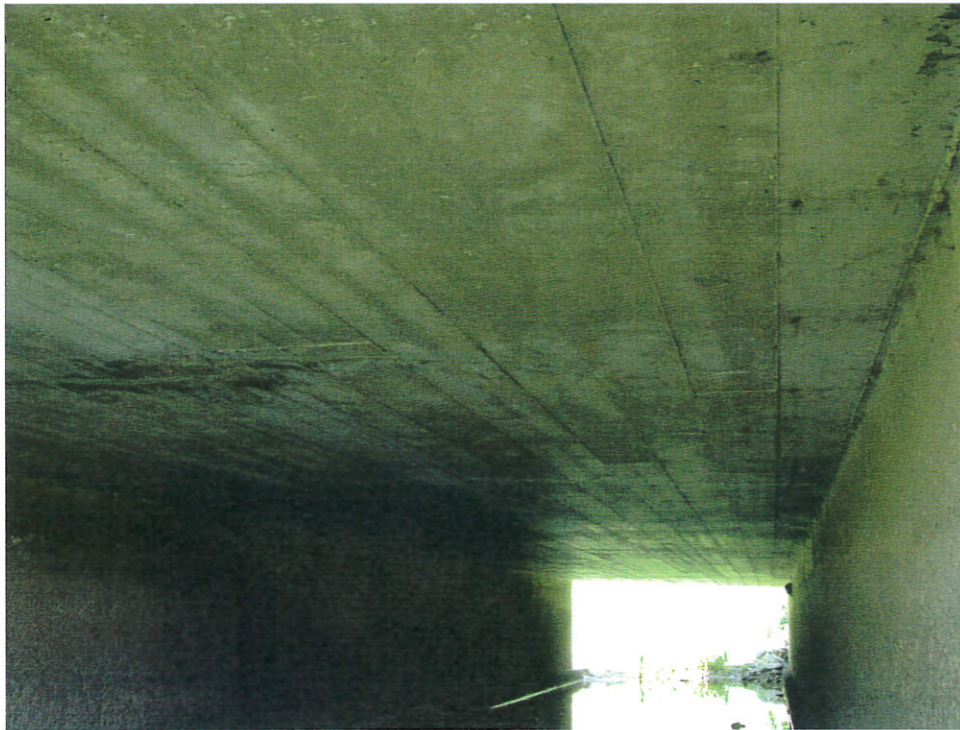
Viewing the interior of the structure, from the south end

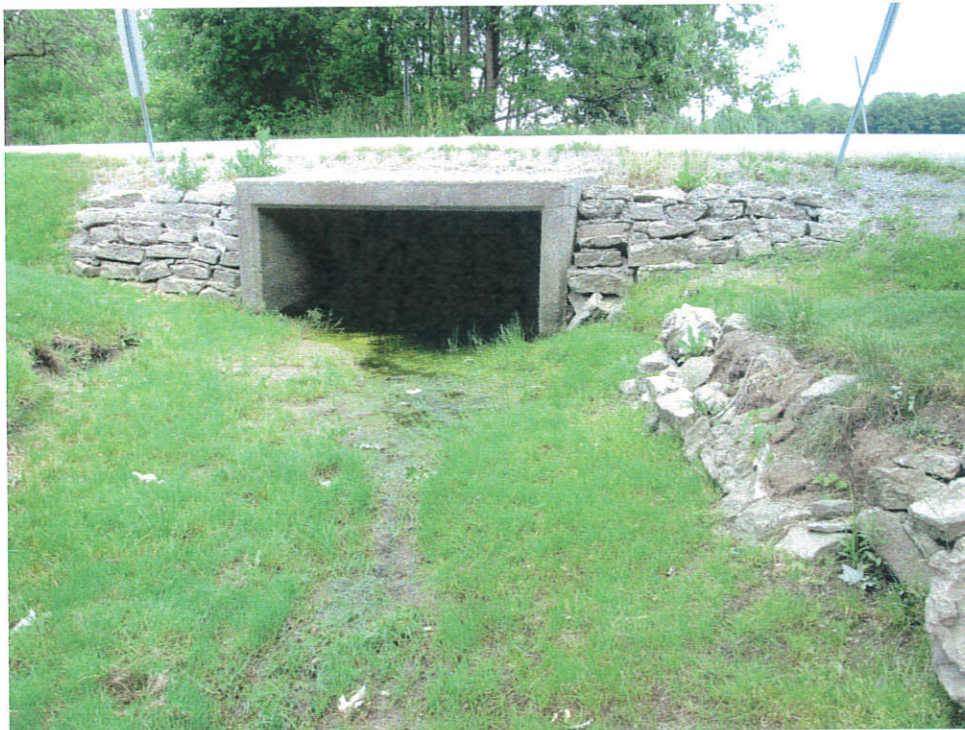
The west end of the structure

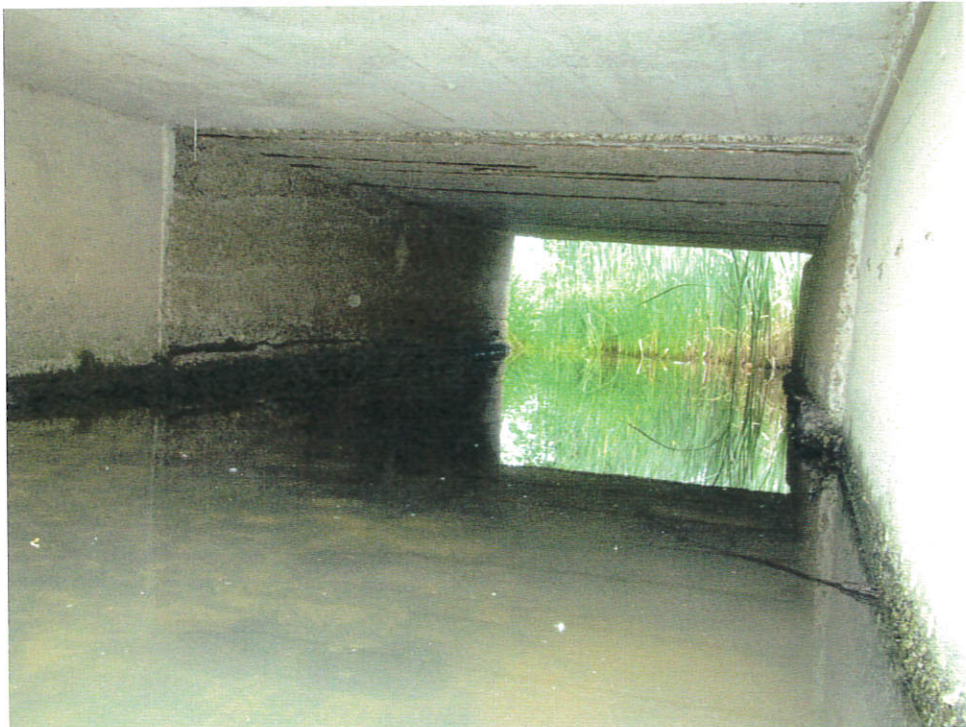
Viewing the interior of the structure from the west end

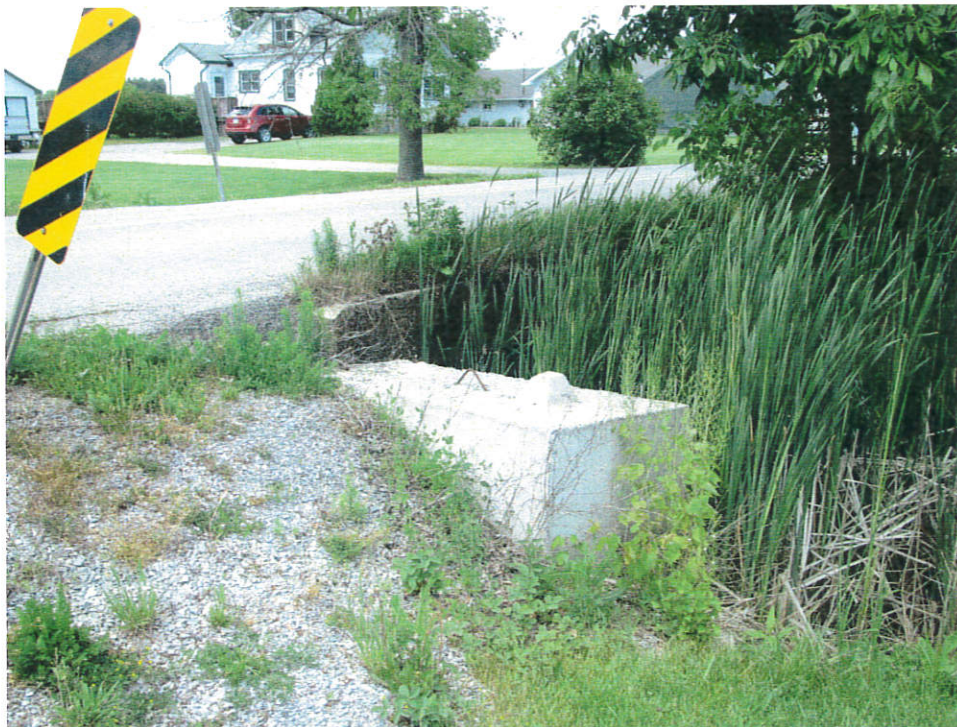
The east end of the structure

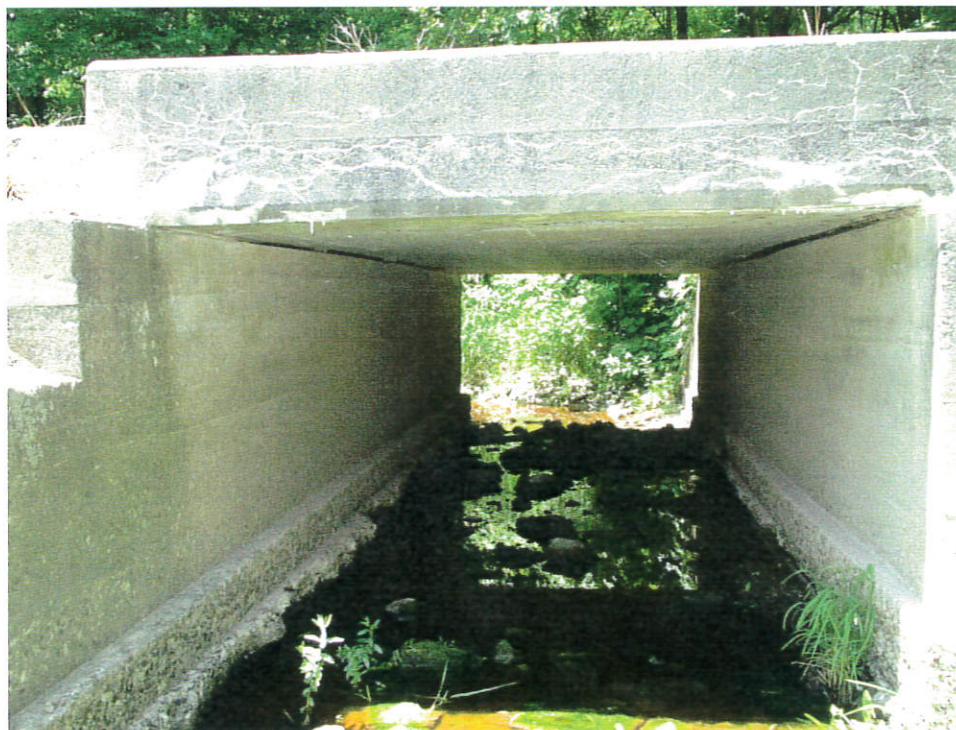
Viewing the interior of the structure from the east end

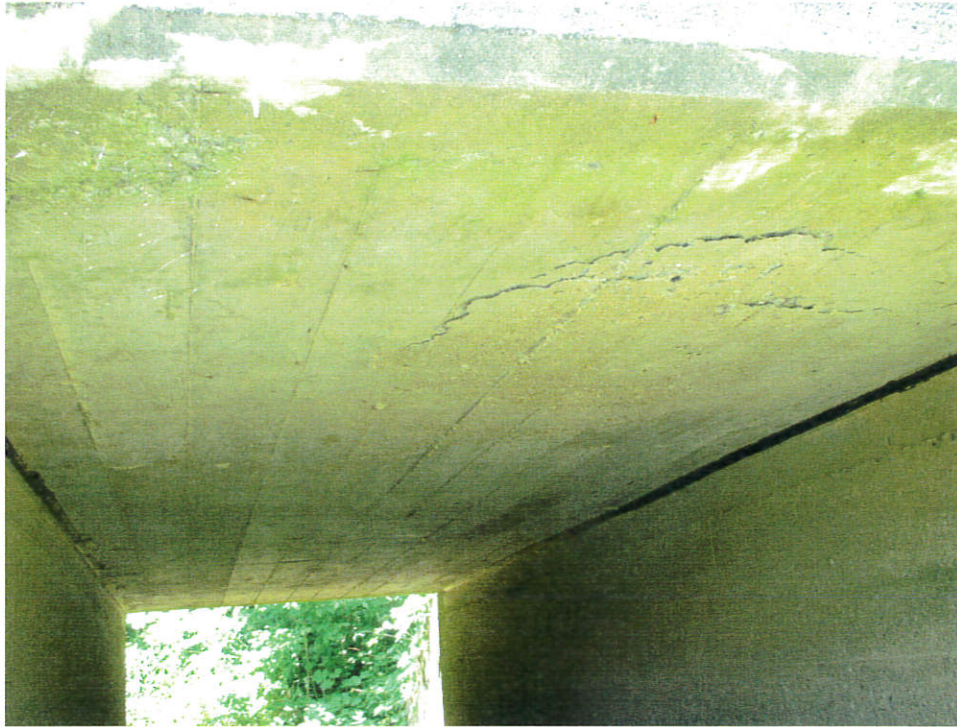
The underside of the structure

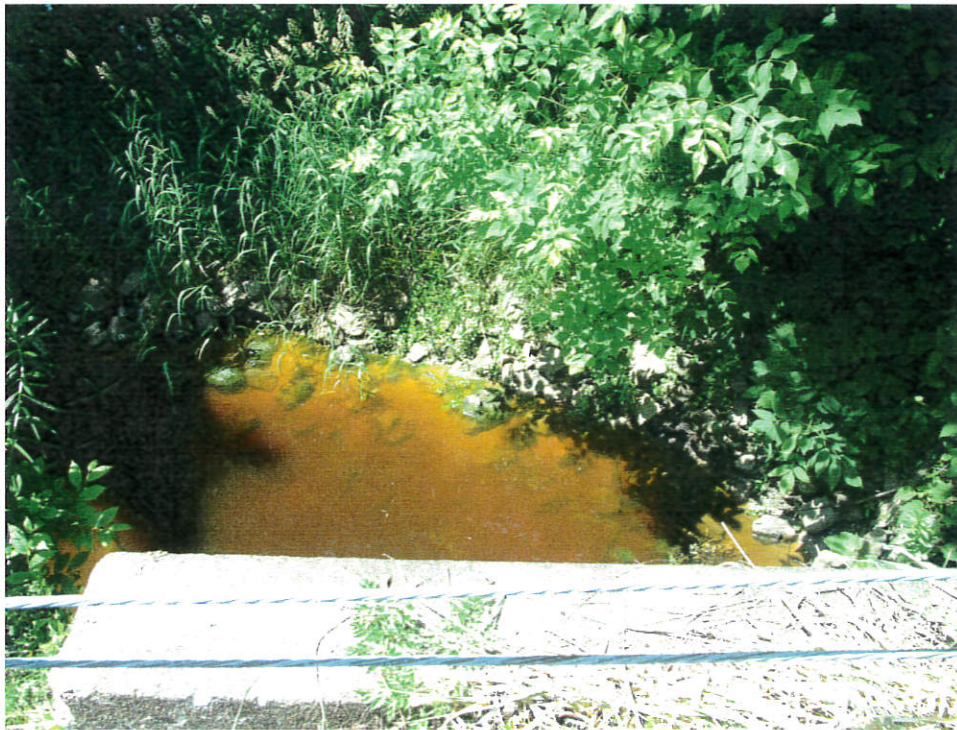
The west end of the structure
