# **Wignell Drain Stormwater Baseline Report**

Project No: EWB-189999

**EWA Engineering Inc.**

**City of Port Colborne  
Wignell Drain Baseline Report**

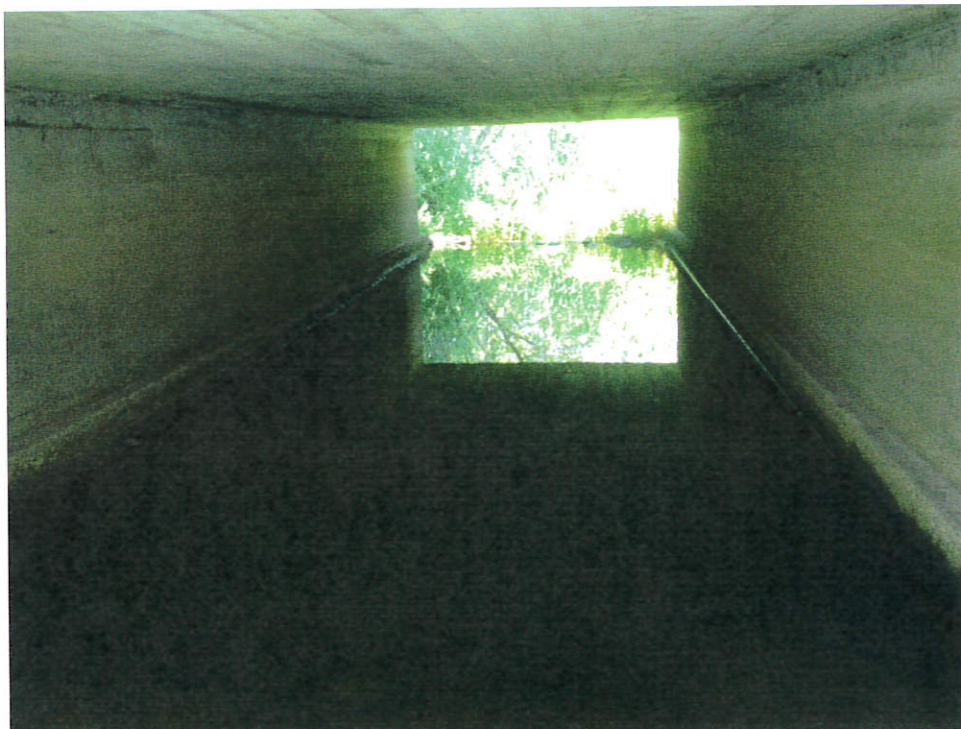
View of the interior of the structure, from the east end

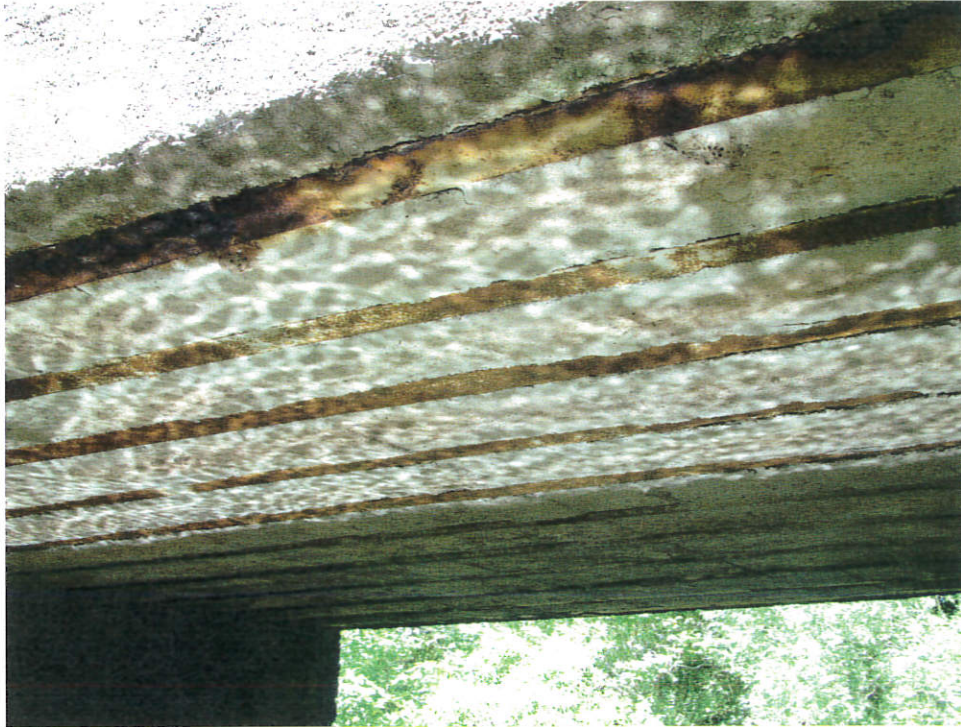
The underside of the structure

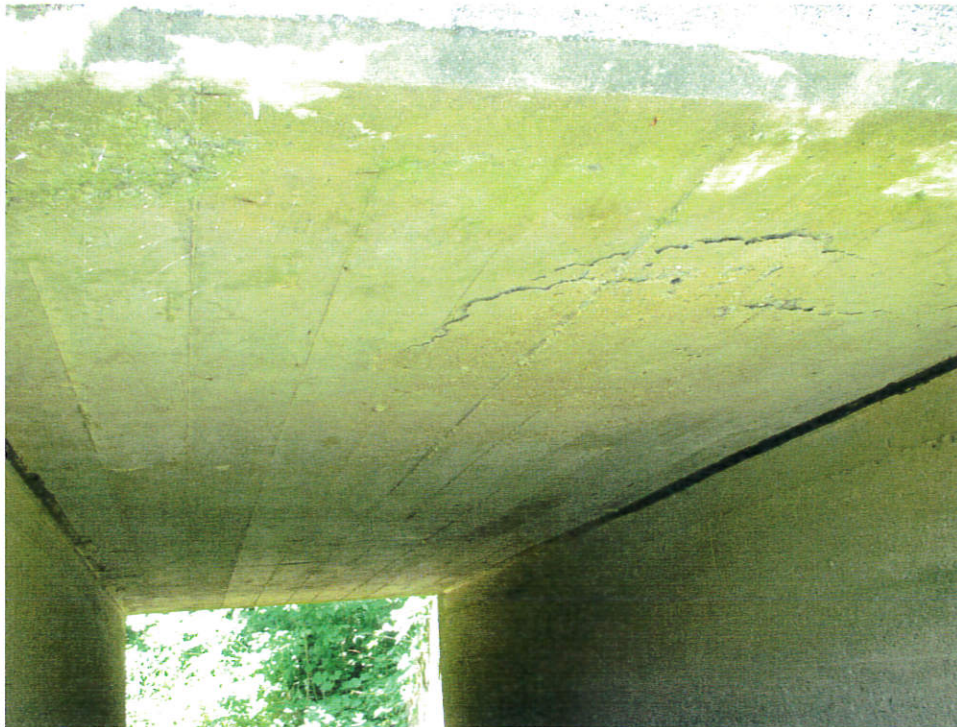
The underside of the structure

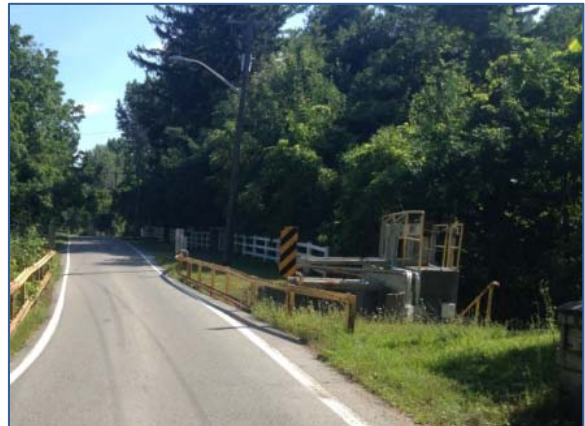
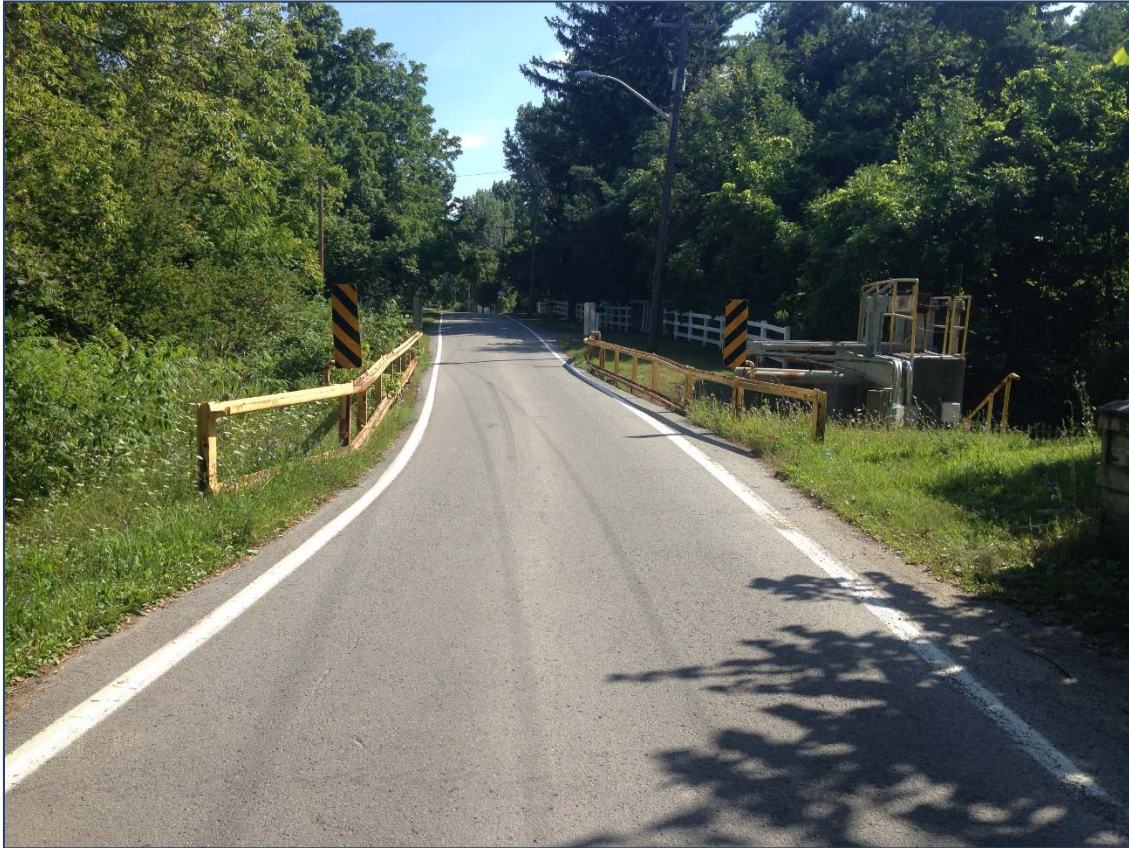
**Figure 1: Wignell/Michener Drain**

The Wignell/Michener dam structure is located immediately downstream of the adjacent roadway, independent of the roadway structure and connected by an infill retaining structure (ref. Figure 1.) The main dam structure consists of a cast-in-place concrete rigid frame, consisting of three (3) cells (ref. Figure 2), complete with structural steel sliding gate and appertunances, railings and piping.

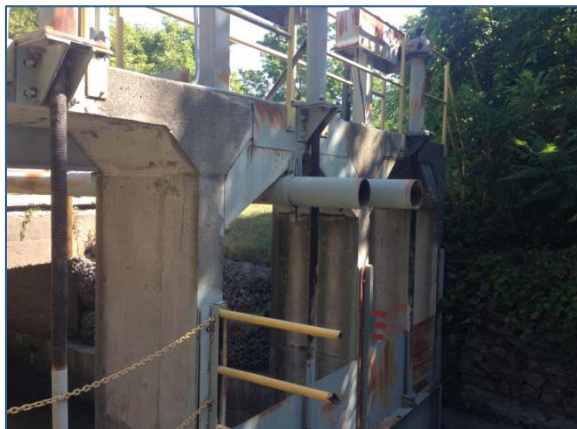
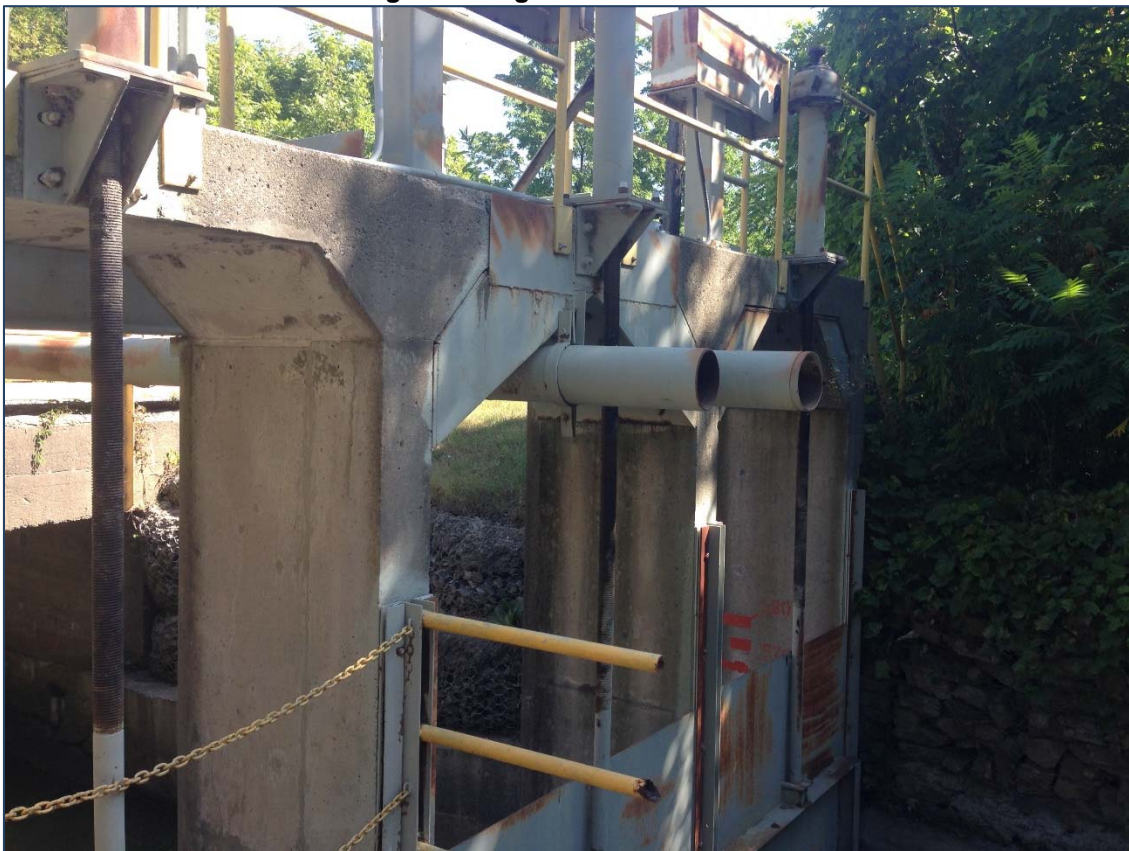
**Figure 2: Downstream Elevation**

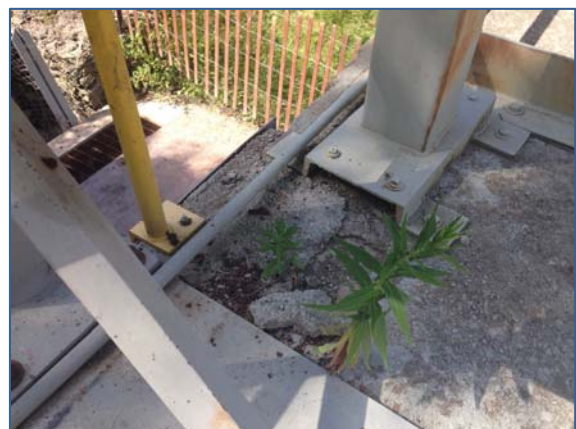
**Figure 3: Localized Concrete Spall**

The west cell has been infilled with dam equipment. The centre and east cells contain coated steel sliding gates. In general, the dam structure is in good condition, with limited, localized areas that contain minor cracks and concrete spalls (ref. Figure 3.) Localized repairs should be completed to the cracked and spalled concrete at the same time when other work is being completed on the dam structure.

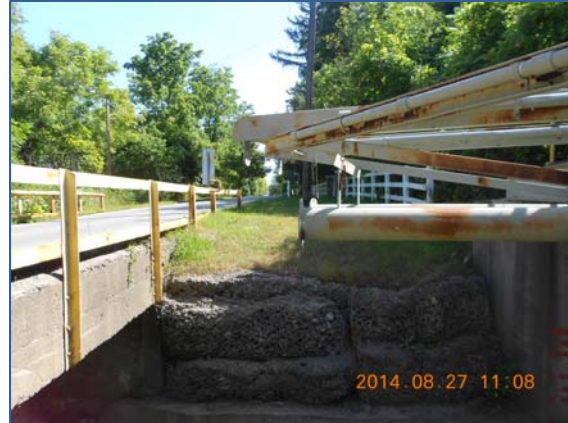
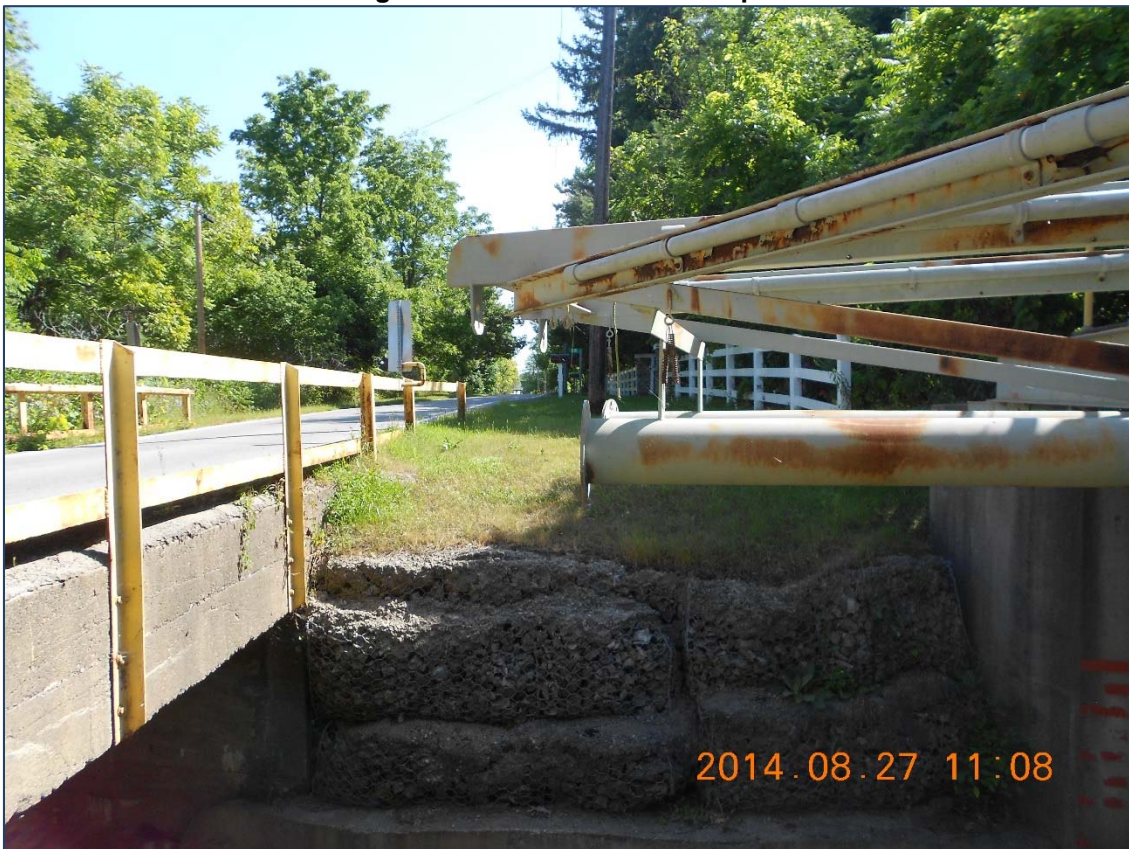
Figure 2: Upstream Embankment

**Figure 4: Upstream Embankment**

The upstream embankment is retained by the the adjacent retaining structures, consisting of a cast-in-place concrete wall supporting an overlying gabion basket wall (ref. Figure 4.) The gabion basket wall has been grouted on the top and inside face. Both the concrete and gabion walls appear to be stable with no noted movement of the wall or retained soil behind the walls.

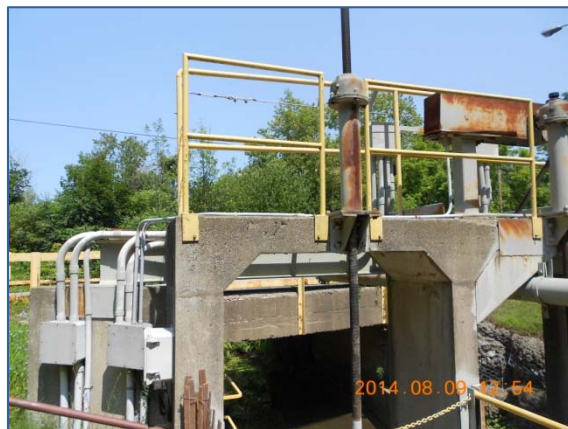
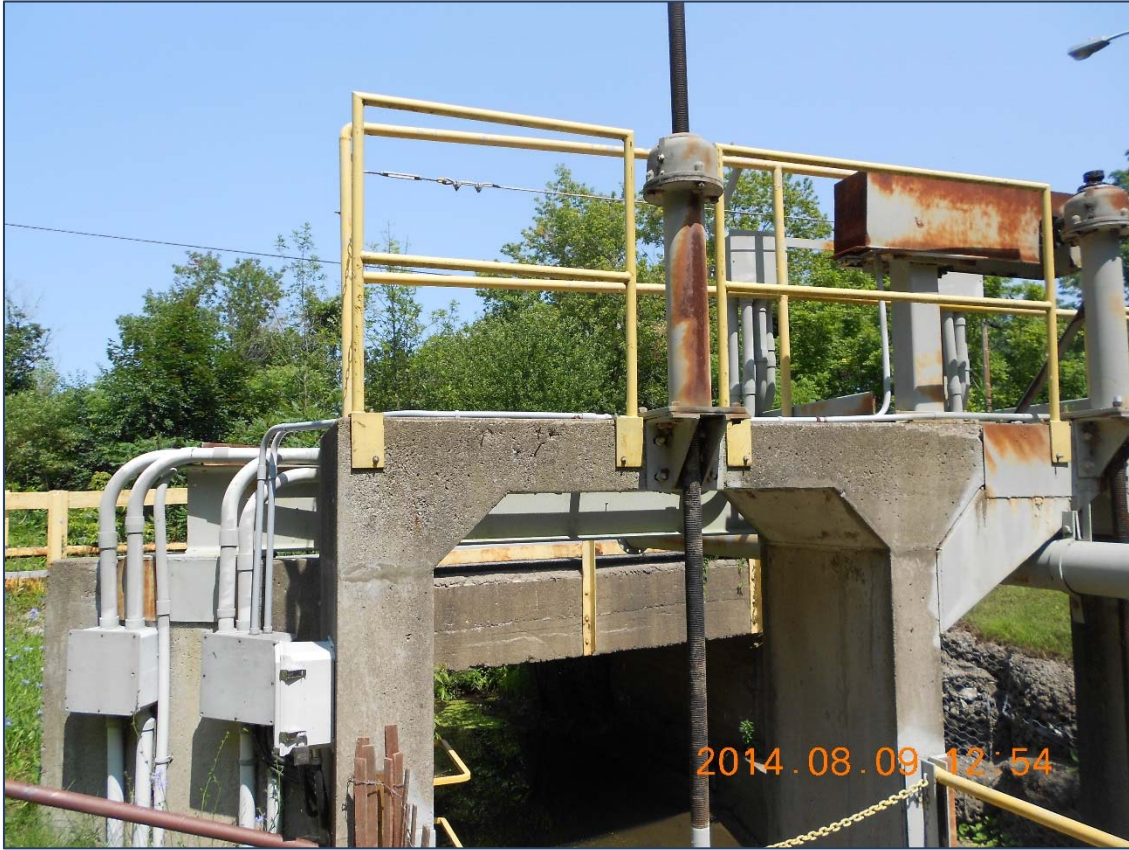
Figure 3: Railings

**Figure 5: Railings: Railings**

The railings located on the dam structure are substandard and do not meet current code requirements. Further, in general terms railings are noted to be in fair condition (ref. Figure 5.) It is recommended that the railings be replaced with a new, hot-dip galvanized steel railing system. Additionally, fencing around the downstream side of the dam structure should be replaced with a more permanent fencing system when future work is completed.

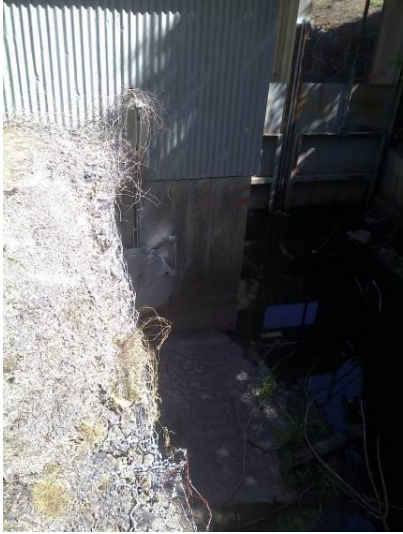
Inspected Area	Photo	Comments & Recommendations
3. South Side

<p>The concrete structure supporting the pump station and well appears.</p>
4. Pump House Internal View

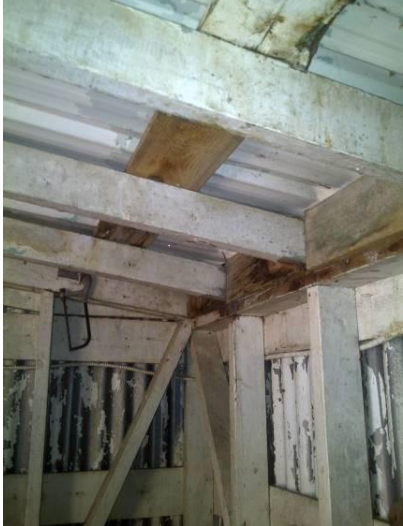
<p>The internal construction of the pump house is in very poor condition. The wooden beams supporting the walls and roofing show significant weather damage and rotting. The corrugated steel walls, floor leak and the room is not properly insulated. This is a very poor environment to house electrical equipment.</p>

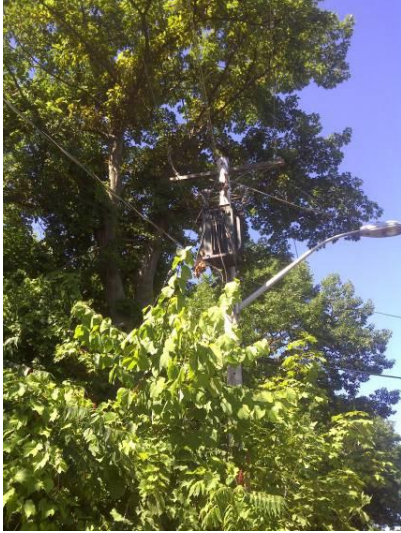
<p>The transformer appears to be quite old and should be replaced. The overhead station feeder lines are susceptible to weather damage and are showing signs of aging. We suggest replacing the transformer and feeder cables.</p>

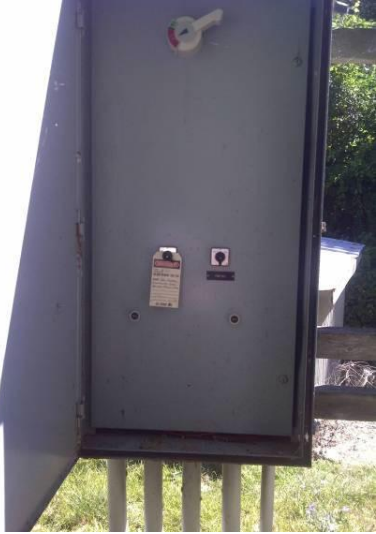
<p>The river pump starter panel has been modified several times over the years and now only provides power and manual control for River Pump 2. The starter panel appears to be in reasonably good condition, but needs minor repairs and clean up.</p>
4. River Pump Power and Starter Panel Structure

A separate feeder runs from the hydro pole to the disconnect and metering equipment (as shown in the picture) to supply power to two river pumps. Only river pump 2 remains installed. River pump 1 has been fully removed. The disconnect equipment is connected directly to the starter panel shown in picture 3. The equipment appears to be in good condition.

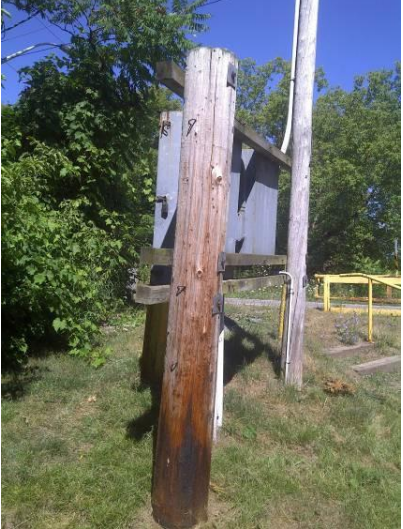
<p>The telegraph-pole structure is beginning to show signs of weather damage and aging, and will need a replacement if the river pump remains in service.</p>

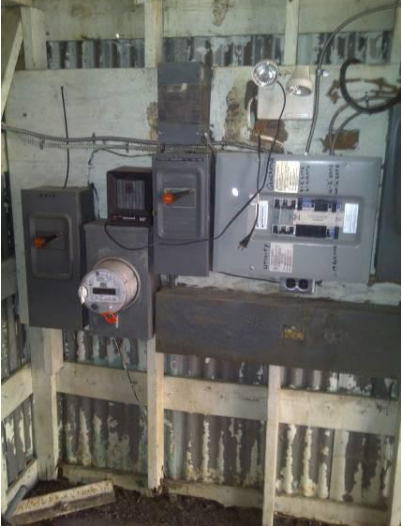
<p>The majority of this equipment is in fair condition, with the exception of the well pump starter and can continue to be used for approximately the next 3 years. However, due to the pump stations structural issues and lack of insulation we recommend replacement.</p>

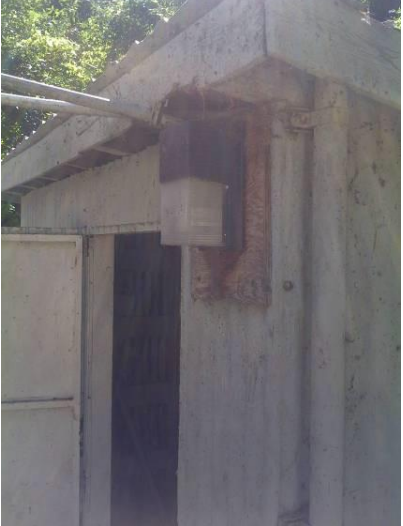
<p>The outdoor light is generally in poor condition, has limited area lighting capacity and is beyond its asset life. We recommend replacing the existing light and adding additional lighting to the dam structure, to ensure that code and health and safety regulations are met.</p>

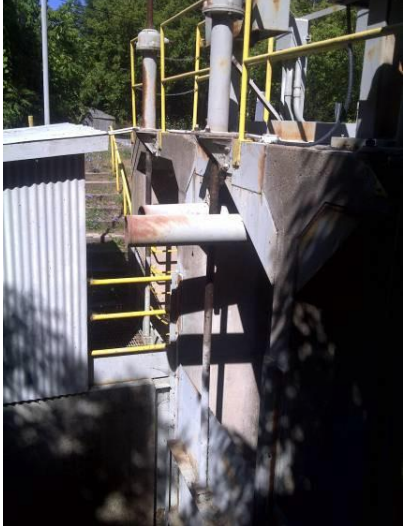
<p>All of the Dam gate mechanisms appear to be in reasonably good condition. The actuators may require minor repair and maintenance to bring them to fully operational condition. The gates and slide have been modified over the last few years and nylon slides have been installed, which will allow the gates to operate more efficiently. We suggest that minor repair and general maintenance be carried out.</p>

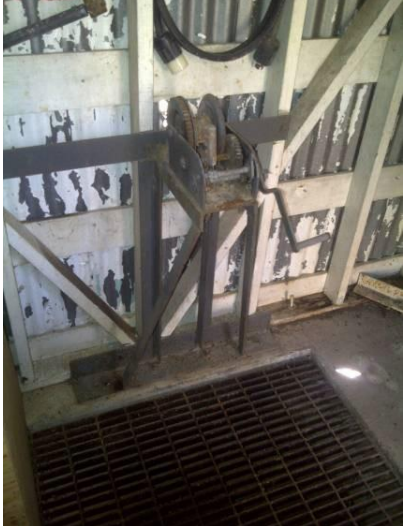
<p>The Hoist appears to be in reasonably good condition.</p>

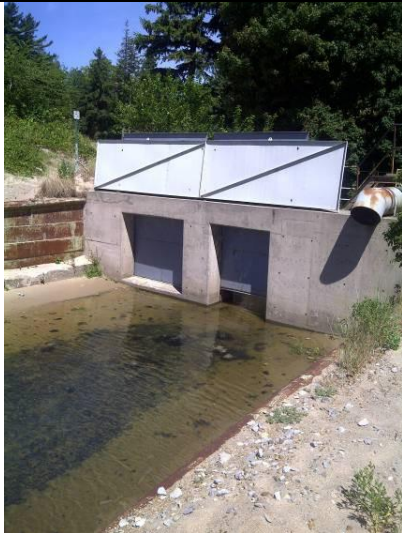
Upstream side Dam
2. Dam Grating - South Side

Downstream side of Dam.

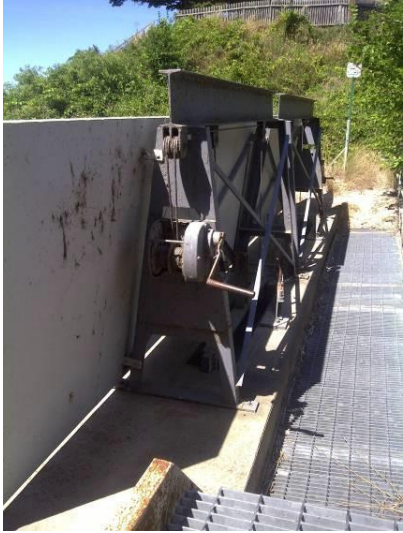
Inspected Area	Photo	Comments & Recommendations
3. Dam gate mechanism

<p>The gates and hoist mechanism are in reasonably good condition.</p> <p>You will not that the protective wind/spray shield mounted to the hoist mechanism were added recently (circa 2009-2010).</p>

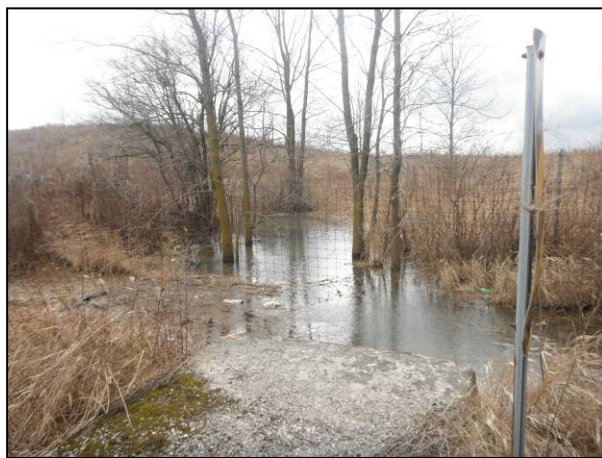
Photo 1: Reach 2-WM channel character

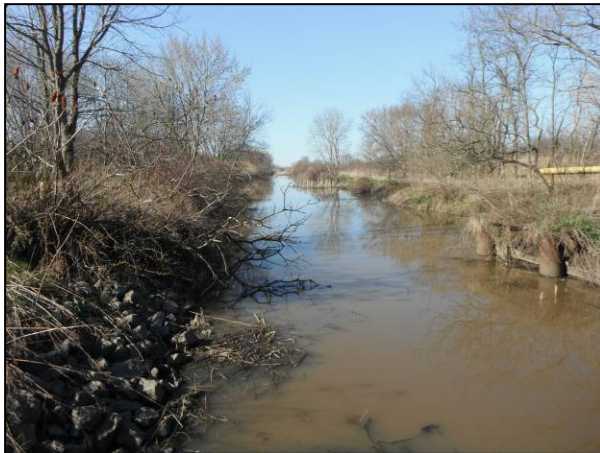
Photo 9: Reach 7-WM showing channel width

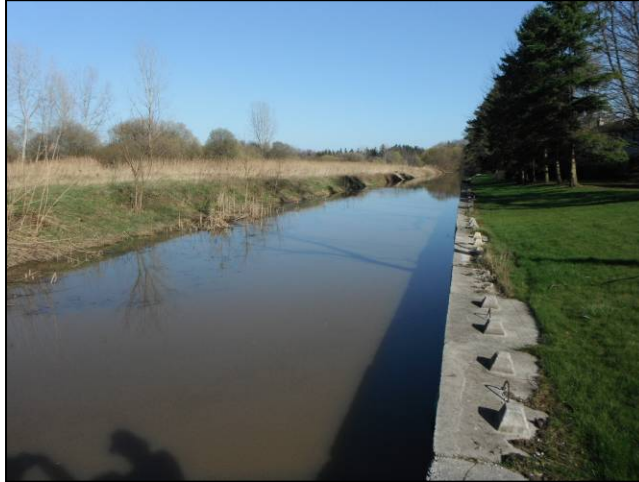
Photo 11: Reach 8-WM, channel character and hardened edge (emergency erosion protection works constructed circa 2008)

Reach 8-WM runs generally east-west along the rear lots of homes which front on Lakeshore Road to the confluence of the Wignell W1 and Michener M2 Drains north of Lakeshore Road. Lands to the north are naturalized cultural meadow and lands to the south are residential.

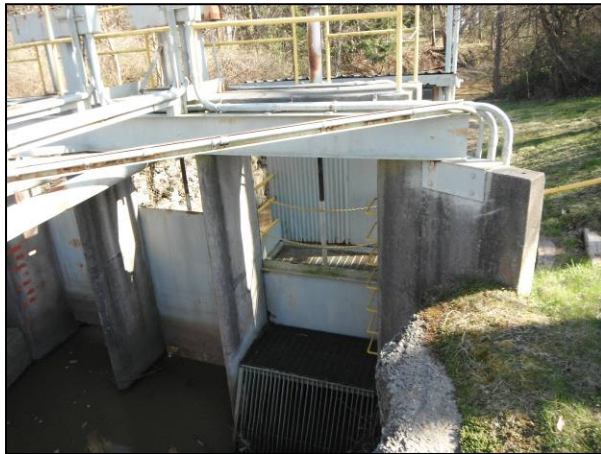
Photo 12: Reach 9-WM, water control structure at Lakeside Road

Reach 9-WM runs generally north-south from the water control structure just south of Lakeshore Road to Lake Erie. This section of the drain runs through a Lake Erie shoreline dune community, which is an upland deciduous forest, and thus has much larger banks and a very different species composition than the rest of the drain.

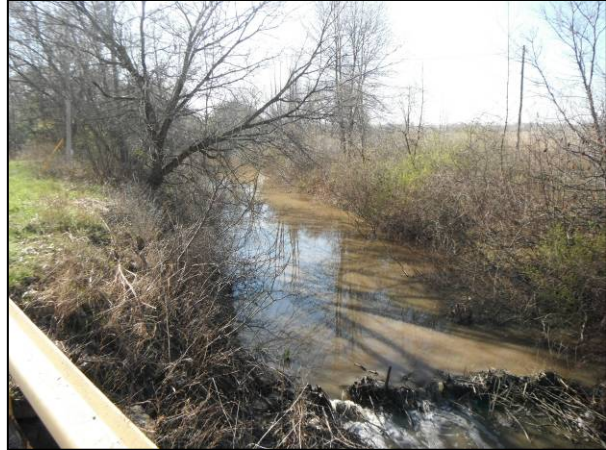
Photo 15: Reach 10-WM, typical drain character, except for beaver dam in foreground of photo

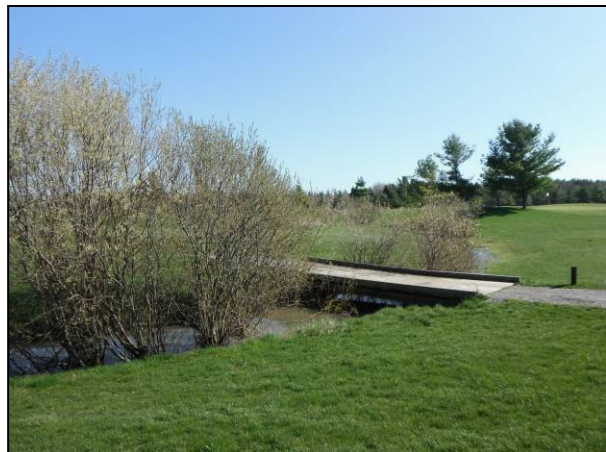
Photo 17: Reach 11-WM, drain crossings and shrubs

Reach 11-WM runs north-south through the Whiskey Run Golf Club. The drain has been altered to have a sinuous shape and is mowed to its edges with occasional small shrubs and cattails within the channel. This shape is the result of the drain being altered/constructed by the property owner without the prescribed requirements of the Drainage Act R.S.O. These works were incorporated afterwards under a Report by Wiebe Engineering Group Inc. dated November 15, 1996. Numerous small bridges cross the drain to facilitate golf cart traffic through the course.

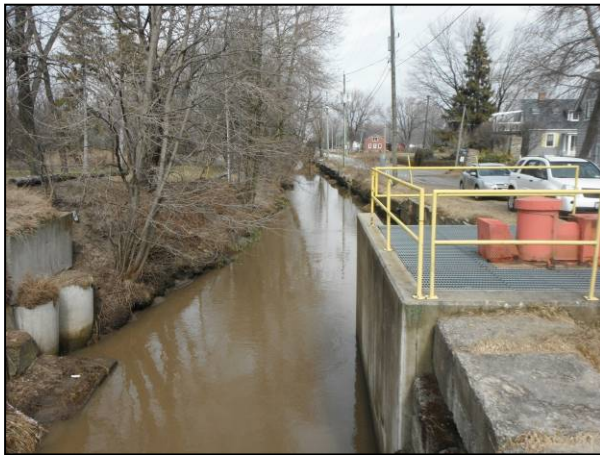
Photo 37: Reach 1-B, water control structure

Reach 1-B runs north-south from Lake Erie to a culvert under Weaver Road. Approximately 50m upstream from Lake Erie is a water control structure that regulates flow into and out of the drain, with a primary purpose of preventing Lake Erie storm surge waters from inundating the drain. Weaver Road runs parallel to the drain on its east side throughout this reach, separated by an excess concrete/precast concrete block retaining wall and a small mowing strip. On the drain's west side the land use is residential, deciduous swamp, and agricultural. The agricultural segment is cultivated to within 1m of the top of bank.

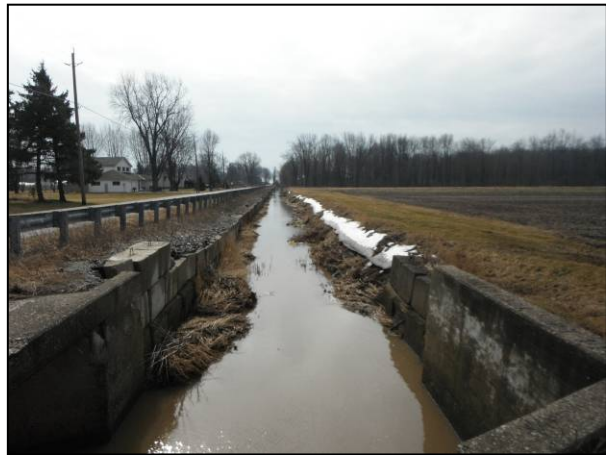
Photo 38: Reach 1-B, hardened banks and adjacent agricultural land

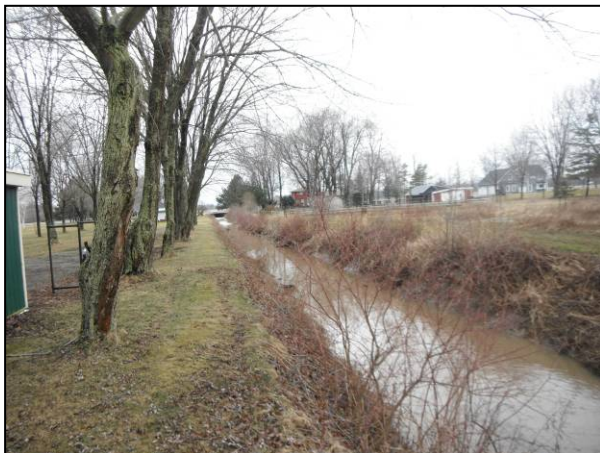
Photo 39: Reach 2a-B channel with adjacent residential land

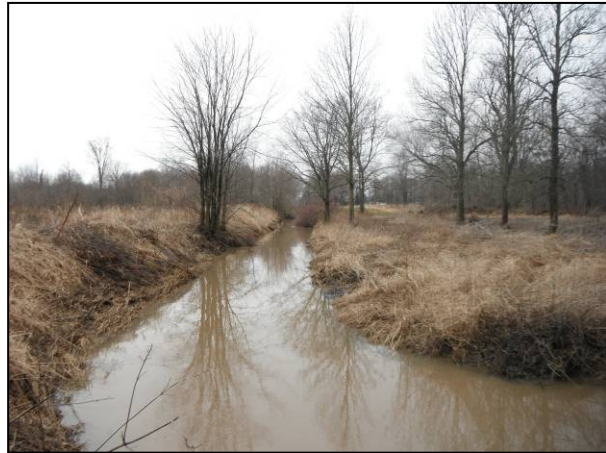
Photo 40: Reach 2b-B, channel and adjacent vegetation

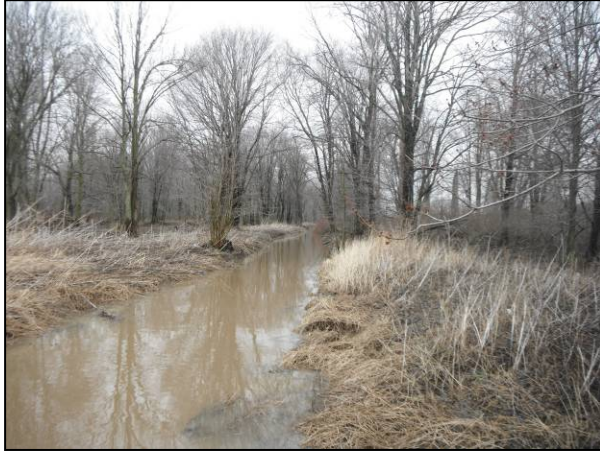
Photo 41: Reach 3-B channel adjacent to deciduous swamp

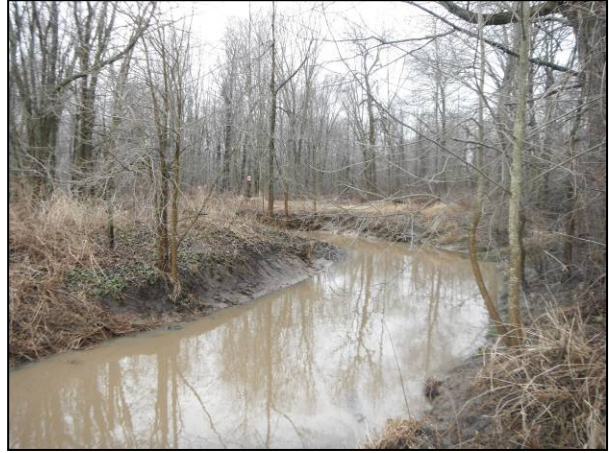
Photo 42: Reach 3-B, channel character

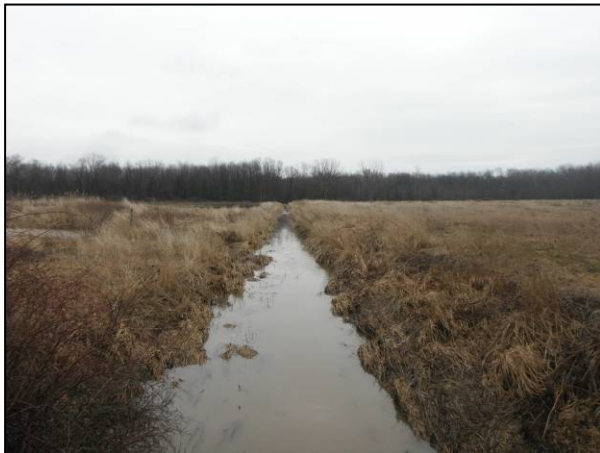
Photo 43: Reach 4-B channel with adjacent agricultural

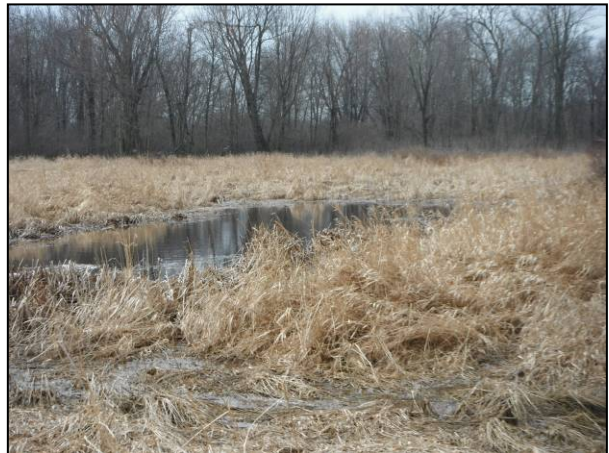
Photo 44: Reach 4-B, flooded field south of channel

Reach 4-B runs east-west through an agricultural field. The field to the north is actively cultivated to the top of bank, while the field to the south is fallow, with dense herbaceous vegetation and one tree. Patches of standing water were observed in the field to the south, possibly indicating a lack of routine drain maintenance, during the field investigation.

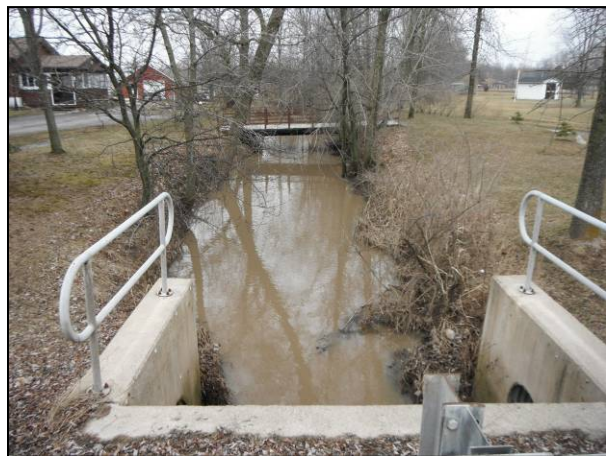
Photo 48: Reach 6a-B, Hwy # 3 culvert crossing headwall & lateral drainage (piped roadside ditching)pipinginterface. Former Geo. A. Schooley Award Drain.

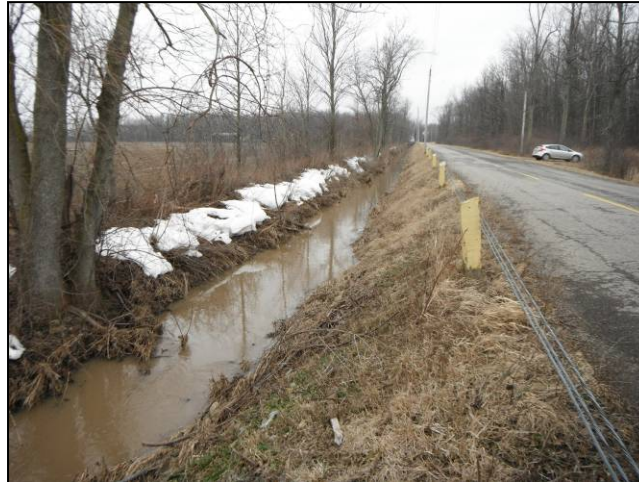
Photo 49: Reach 6b-B, channel character adjacent to White Rd.

Reach 6b-B runs north-south adjacent to White Road on the road’s west side. The profile of the drain follows the existing elevation/contour of the bedrock along this reach; the design grade has never been achieved here since 1916. The adjacent land use on the drain’s west side through the southern half of this reach is agricultural, while the northern half is deciduous swamp. Three driveway bridges, circular steel/corrugated steel pipe structures, span the drain through this reach.

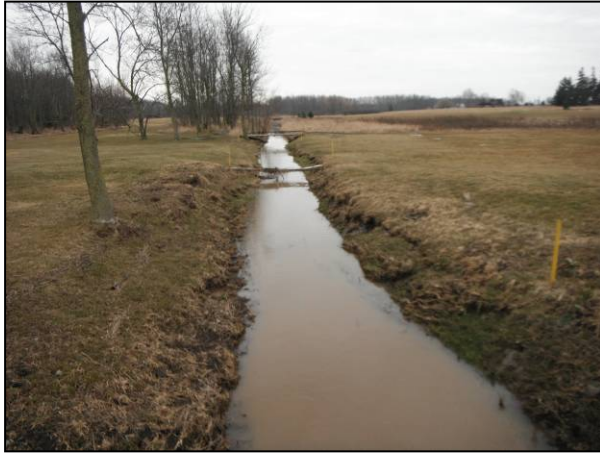
Photo 52: Reach 9-B, channel through golf course with crossings

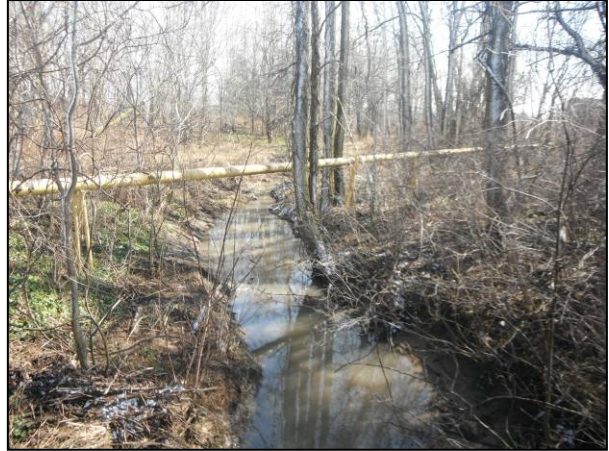
Photo 61: Reach 13-B, pipe crossing the drain and adjacent forest

Reach 13-B, the West Branch of the Beaver Dam Drain, runs generally east-west between an industrial property, a former residential property, and agricultural land, ending at a deciduous forest that fronts onto Miller Road. The reach is generally treed to the top of bank except through parts of the agricultural area. Some concrete structures, pipes, and a bridge associated with the adjacent waste treatment facility have been installed in this reach of the drain.

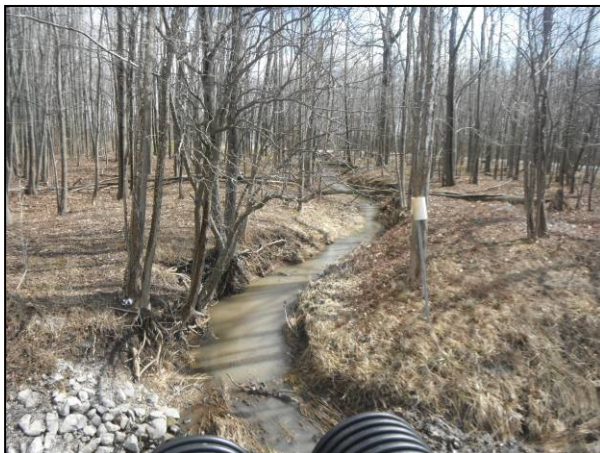
Photo 62: Reach 14-B, channel character, Miller Road cross culvert at point of discharge of roadside ditching system into the West Branch of Beaver Dam Drain.
